**IN-STREAM HABITAT COMPLEXING,
1997**

- Pilot Testing -

*NECHAKO FISHERIES CONSERVATION PROGRAM
Technical Report No. RM97-2*

Prepared by:
Triton Environmental Consultants Ltd.
January 2003

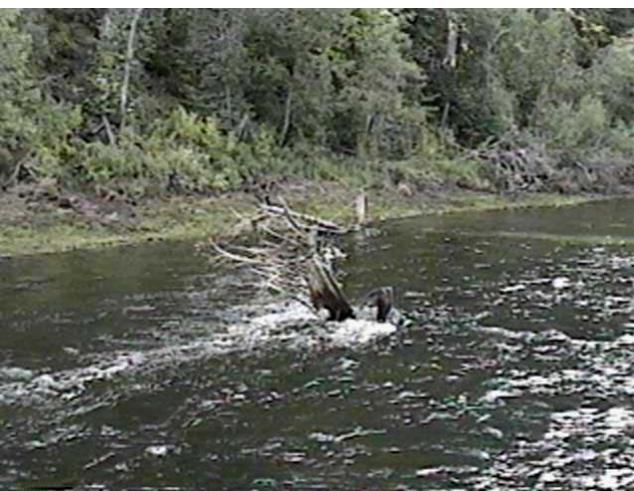
Sept. 9, 1997 - MC15.7 Pocket Pool (82.6m³/s)
Constructed in 1991, the pocket pool consists of a 1 meter deep depression, excavated into the substrate in an area of shallow water, and has remained relatively stable.

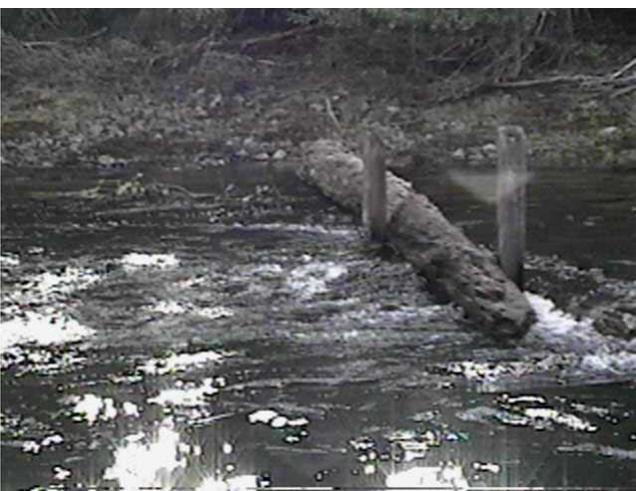
Sept. 9, 1997-RM16.2 Rail Anchored Sweeper (82.6m³/s)
Constructed in 1991, this structure has failed to capture new debris, and has slowly been reduced in size due to defoliation of the sweeper.

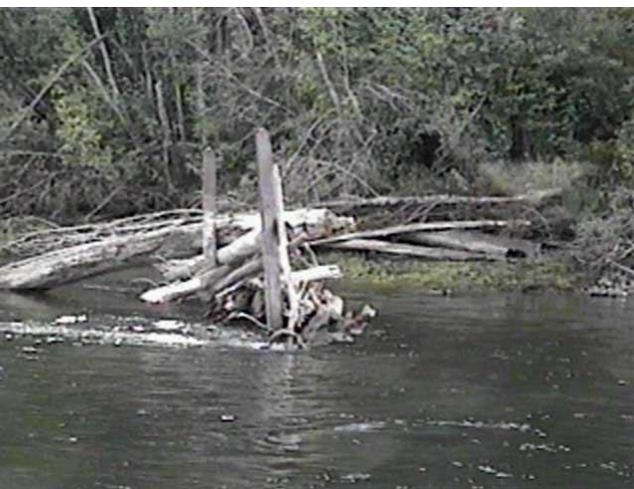
Sept. 9, 1997 - RM16.5 Rail Debris Catcher (82.6m³/s)
Constructed in 1991, the structures shore debris boom was broken causing the structure to lose most of the debris, and preventing the capture of new material.

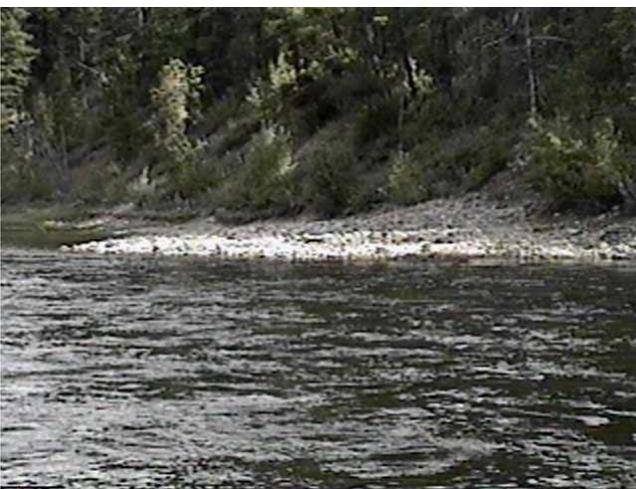
Sept. 9, 1997 - RM16.8 Rail Debris Catcher (82.6m³/s)
Constructed in 1991, failure of the shore debris boom has also caused this structure to lose most of the debris and prevents the structure from capturing new material.

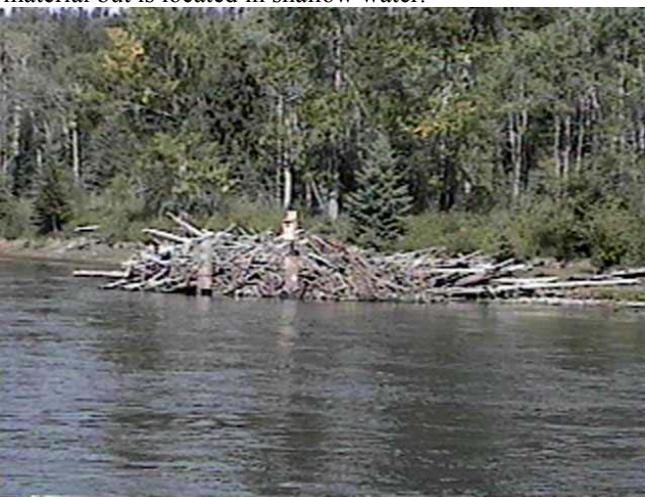
Sept. 9, 1997 - RM17.9 Side Channel (82.6m³/s)
Constructed in 1988 and modified in 1990 to remove material that was reducing velocities, the side channel currently has extremely low velocities due to a beaver dam at approximately the mid point of the channel.

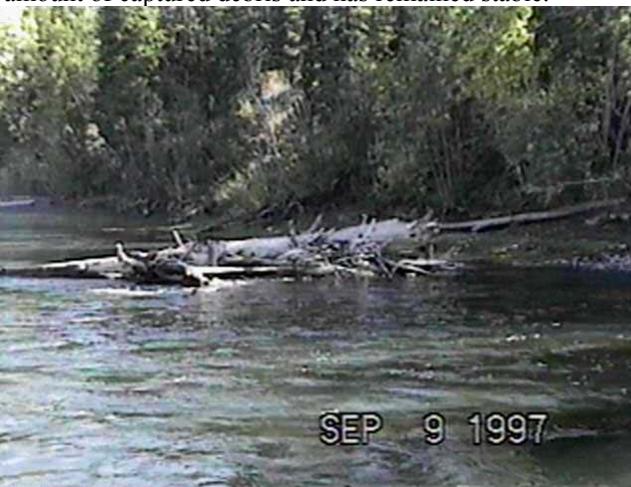
Sept. 9, 1997 - LM21.4 Rail Debris Catcher (82.6m³/s)
Constructed in 1990, this structure trapped a large amount of debris after construction and was colonized by beavers in 1996.

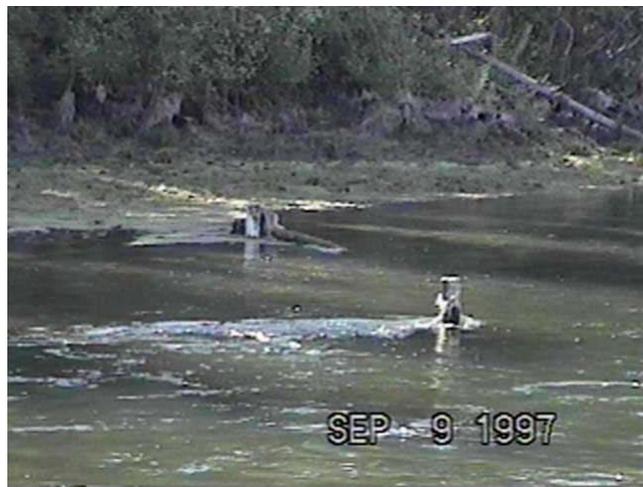
Sept. 9, 1997 - RM22.0 Rail Debris Catcher (82.6m³/s)
Constructed in 1991, this structure trapped a large amount of debris after construction. Damage to the shore debris boom caused the loss of some material but the structure has remained stable.

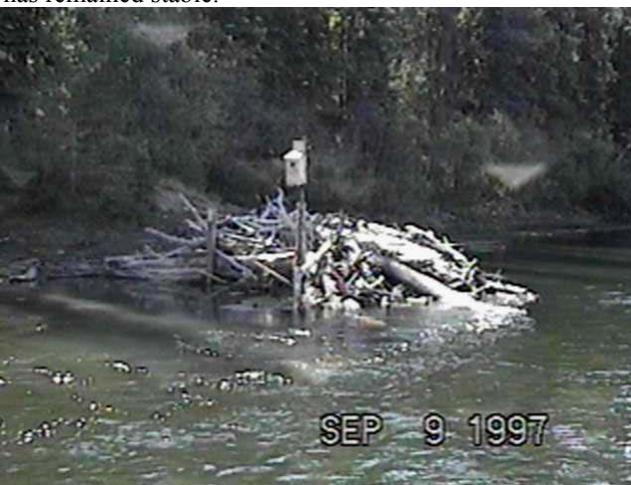
Sept. 9, 1997-RM22.1 Rail Anchored Sweeper (82.6m³/s)
Constructed in 1991, the sweeper has been broken away from the rails. The rails, which are submerged at high flows are failing to capture woody debris.

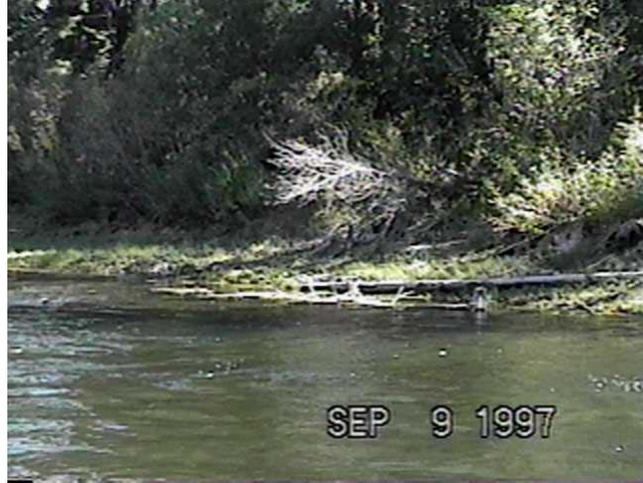
Sept. 9, 1997 - LM 22.85 Rail Debris Catcher (82.6m³/s)
Constructed in 1990, this structure has slowly accumulated woody debris and continues to remain stable.

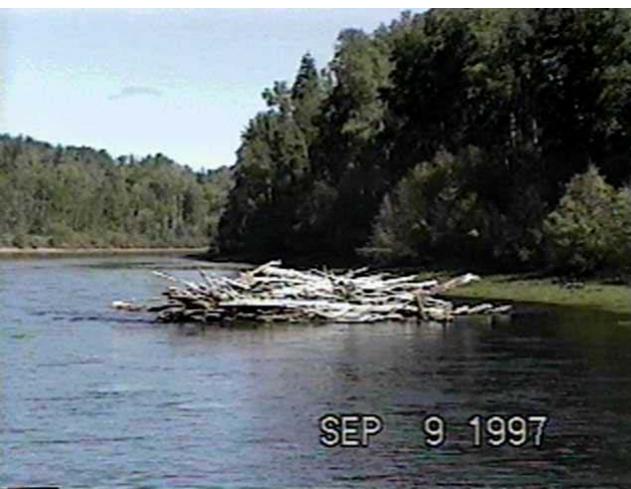
Sept.9,1997-RM22.95 Rail Anchored Sweeper(82.6m³/s)
Constructed in 1991 this structure is almost completely submerged at high flows and fails to trap woody debris. It has slowly deteriorated in size over time due to defoliation.

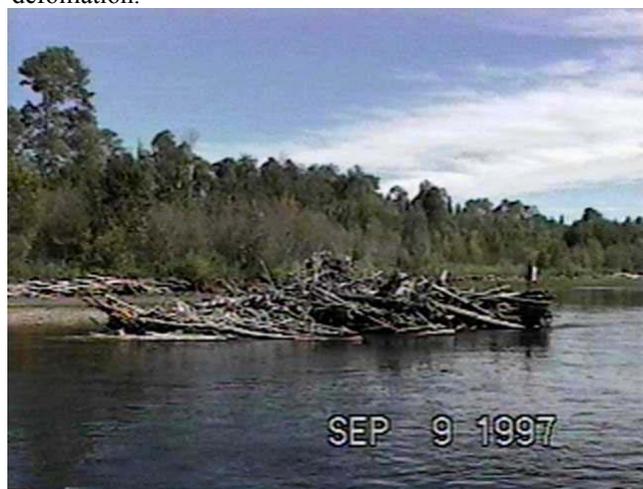
Sept. 9, 1997 - RM23.0 Rail Debris Catcher (82.6m³/s)
Constructed in 1991, this structure trapped a large amount of material after construction, and has remained stable.

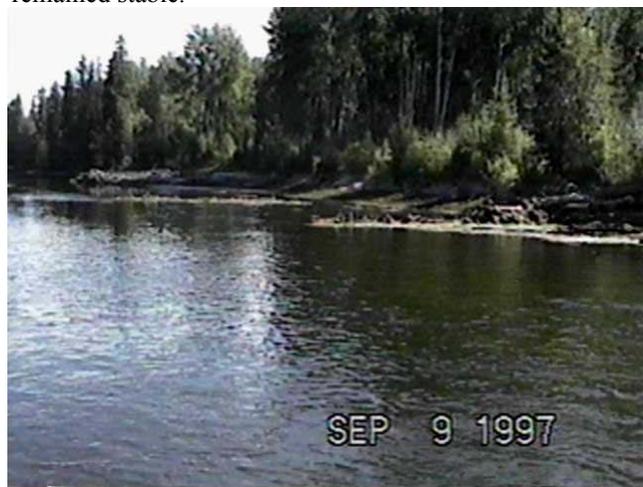
Sept. 9, 1997 - LM24.3 Rail Debris Catcher (82.6m³/s)
Constructed in 1990, this structure originally did not trap much woody debris, but over time has accumulated material and has remained stable.

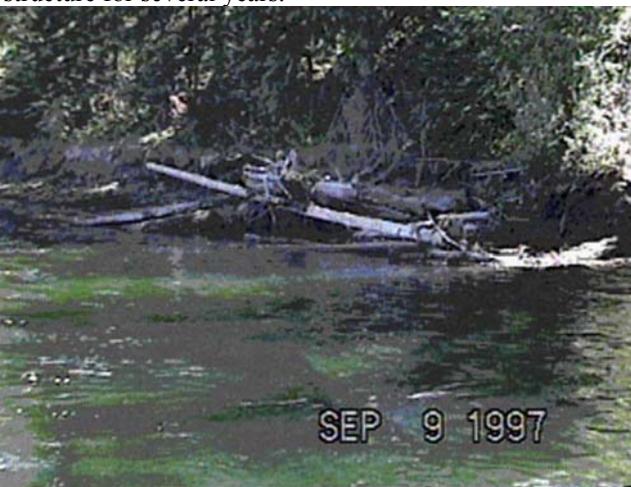
Sept. 9, 1997 - RM24.6 Pseudo Beaver Lodge (82.6m³/s)
Constructed in 1989, this structure had some success with debris entrapment. It is currently maintaining a small pile of woody debris.

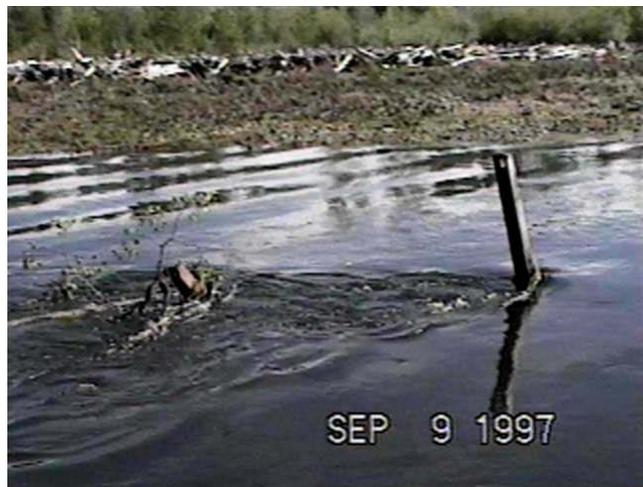
Sept. 9, 1997 - RM28.4 Pseudo Beaver Lodge (82.6m³/s)
Constructed 1989, this structure fails to trap woody debris despite several efforts at modification and is only creating a very small area of cover. Most debris is on the shore.

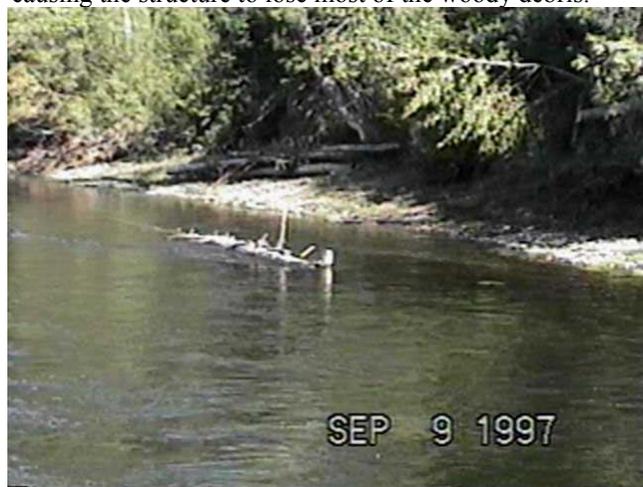
Sept. 9, 1997 - MC25.7 Rail debris Catcher (82.6m³/s)
Constructed in 1991, this structure has accumulated a small amount of material, and has remained relatively stable over time.

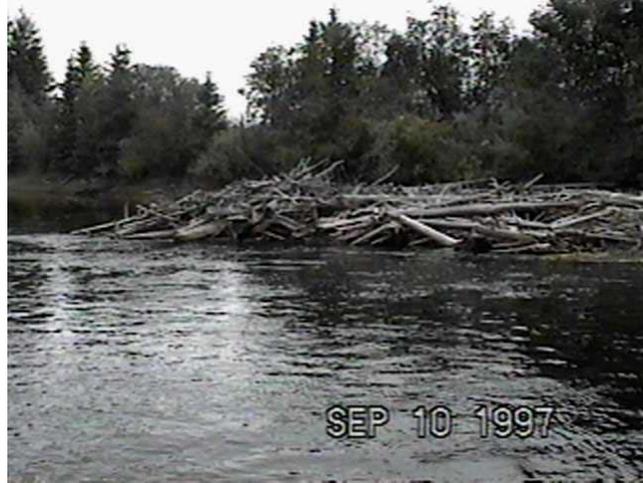
Sept. 10, 1997 - RM27.4 Floating Crib (82.6m³/s)
Constructed in 1989, and modified in 1991 with additional rail anchors for stability, the failure of the rail anchors, and downstream boom, caused the structure to shift downstream partially on to the shore.

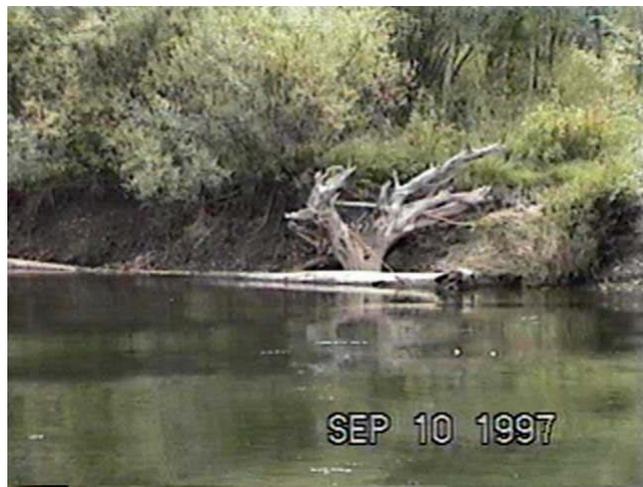
Sept. 10, 1997 - RM3.1 Pseudo Beaver Lodge (82.6m³/s)
Constructed 1989, this structure fails to trap woody debris despite several efforts at modification, and is creating almost no cover as the structure has been reduced to bare logs.

In 1996, complex RM31.1PBL failed and in 1997 it completely collapsed and lost all cover area. It was recommended that this structure be removed from further assessment. There is currently only one structure remaining which offers cover area within the design criteria range. Due to debris retention problems it is not recommended that further units be constructed.

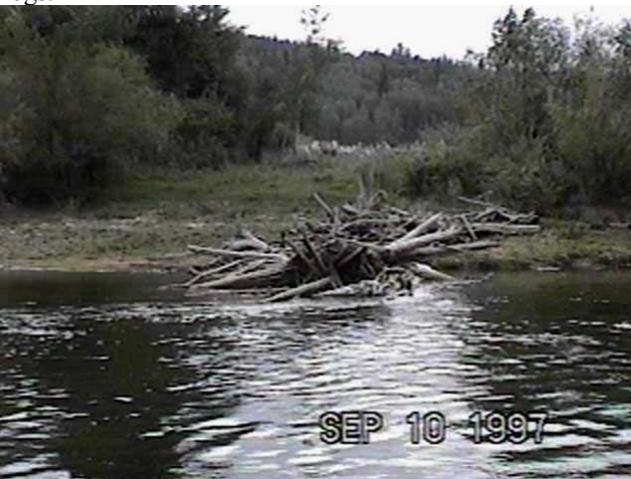
Sept. 10, 1997 - RM31.4 Brushpile (82.6m³/s)
Constructed in 1988, this structure has not trapped new debris, and the slow loss of and deterioration of seeded material have slowly reduced the size of the structure.

The brush pile complex installed in 1988 has remained stable. However, cover area has decreased from a high of 37 m² in the spring of 1991 to 1 m² in the fall of 1997. Due to its lack of cover area and the continued degradation of this complex the structure has been recommended for removal from further assessment.

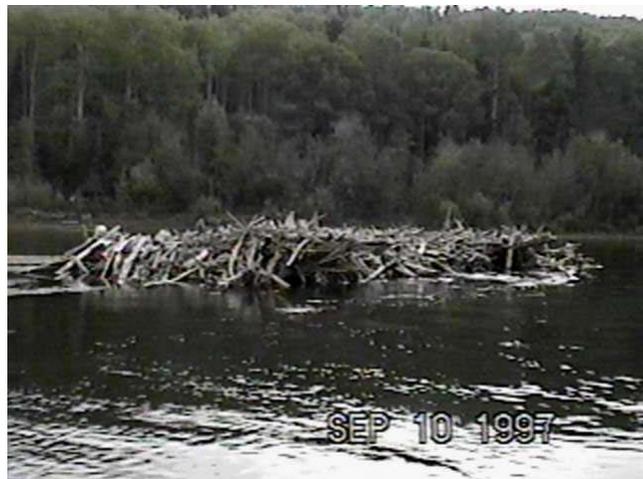
Sept. 10, 1997-RM34.7 Pipe Pile Debris Catcher (82.6m³/s)
Constructed in 1989, this structure captured a large amount of material after construction, but failure of the outer pipe pile caused a significant reduction in the size of the structure.

Two pipe-piles that had failed on the small complex RM34.7PDC in 1995 were recommended for removal because of the potential navigational hazard they represented as they rested just below the water surface at low flows. Five rail debris catchers were recommended for repair, two were recommended for removal, one was recommended for reseeding and one was recommended to be rebuilt closer to shore.

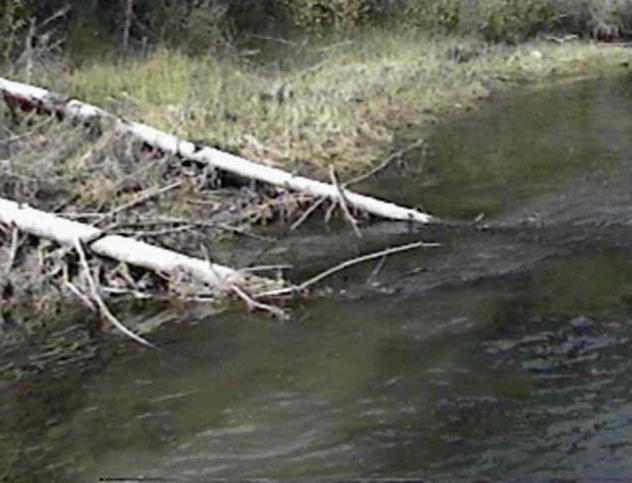
Sept. 10, 1997 -MC35.4 Pipe-Pile Debris Catcher (82.6m³/s)
Constructed in 1989, this structure captured a large amount of material after construction. It was colonized by beavers several years later and has remained stable.

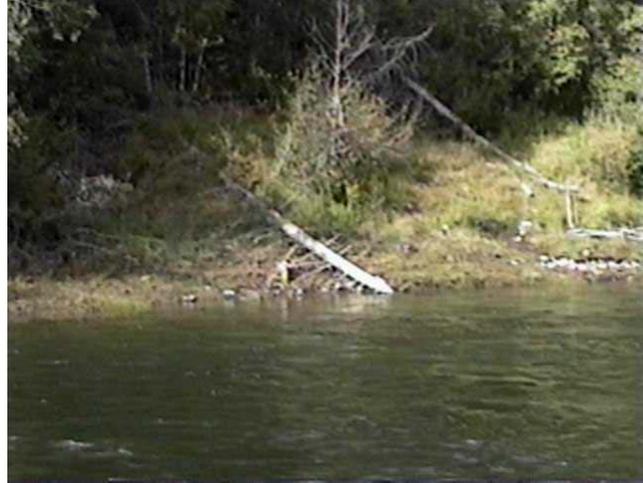
Sept. 8, 1997–LM73..9 Hand Anchored Sweeper (82.6m³/s)
Constructed in 1991, and modified in 1993 with the addition of a downstream boom, this structure generally fails to trap large woody debris and has deteriorated over time and been reduced in size.

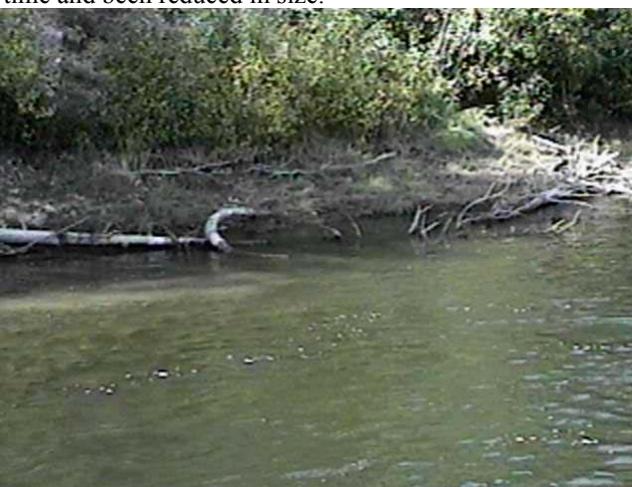
Sept. 8, 1997–LM74.0 Hand Anchored Sweeper (82.6m³/s)
Constructed in 1991, this structure generally fails to trap large woody debris, and has deteriorated over time, and been reduced in size.

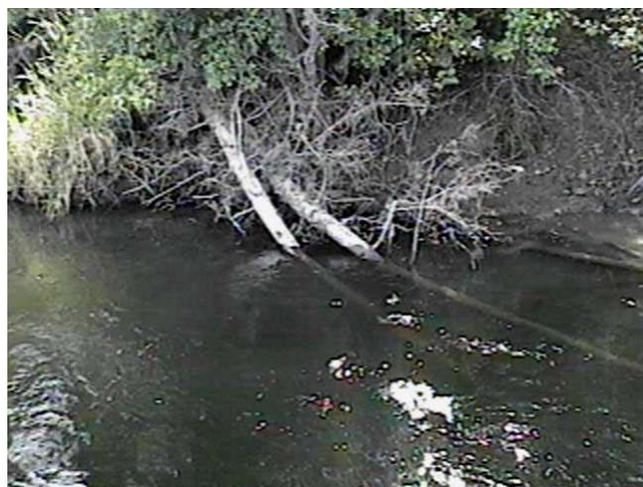
Sept. 8, 1997–LM75..9 Hand Anchored Sweeper (82.6m³/s)
Constructed in 1991, and modified in 1993 with the addition of a downstream boom, this structure generally fails to trap large woody debris and has deteriorated over time and been reduced in size.

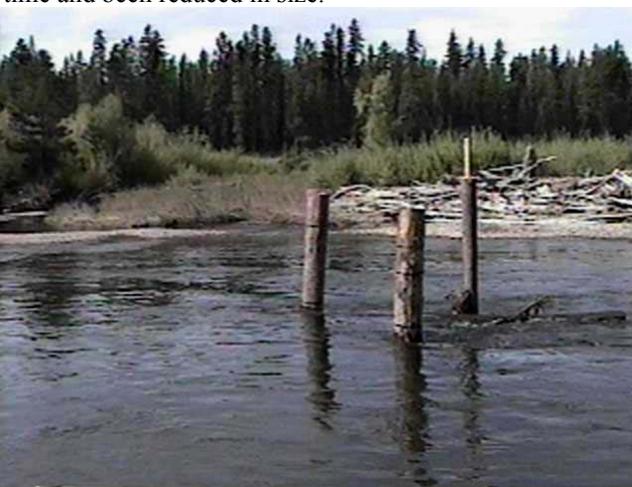
Sept. 8, 1997–LM78.0 Hand Anchored Sweeper (82.6m³/s)
Constructed in 1991, this structure generally fails to trap large woody debris, and has deteriorated over time, and been reduced in size.

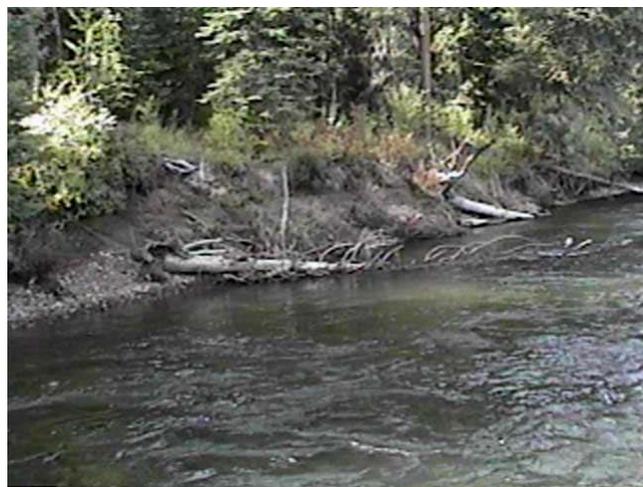
Sept. 8, 1997 – LM80.9 Rail debris Catcher (82.6m³/s)
Constructed in 1991, and modified in 1997 with the addition of rail covers, this structure has generally failed to trap new debris and was slowly being reduced in size.

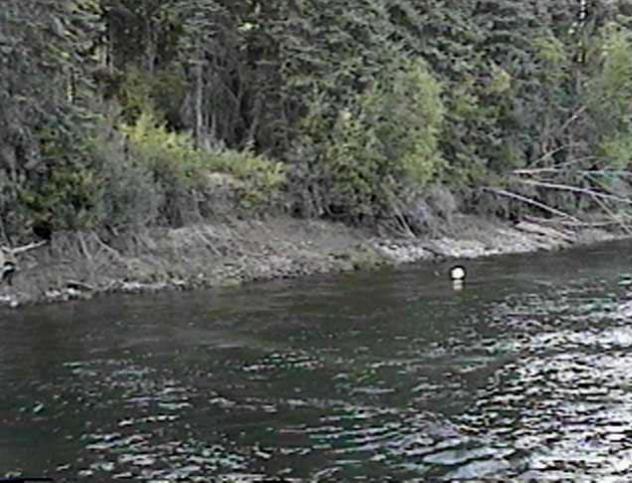
Sept. 8, 1997–LM82.1 Rail Anchored Sweeper (82.6m³/s)
Constructed in 1991, and modified in 1993 with the addition of a downstream boom, this structure generally fails to trap large woody debris, and has deteriorated over time, and been reduced in size.

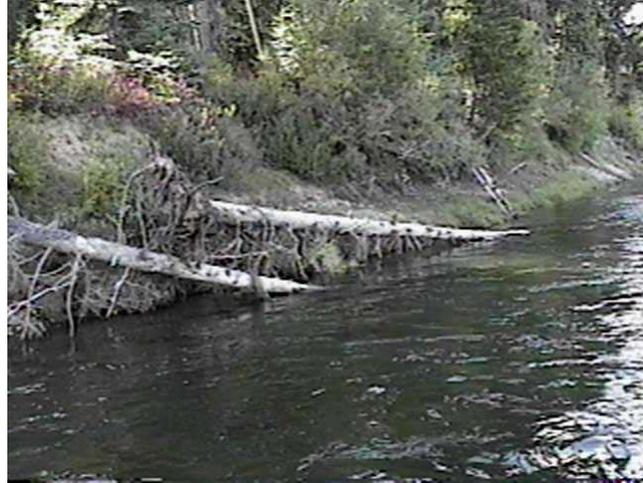
Sept. 8, 1997 – LM82.2 Rail Anchored Sweeper (82.6m³/s)
Constructed in 1991, this structure generally failed to trap large woody debris, and the entire sweeper was lost in 1997. The rail has been marked to avoid becoming a hazard to navigation.

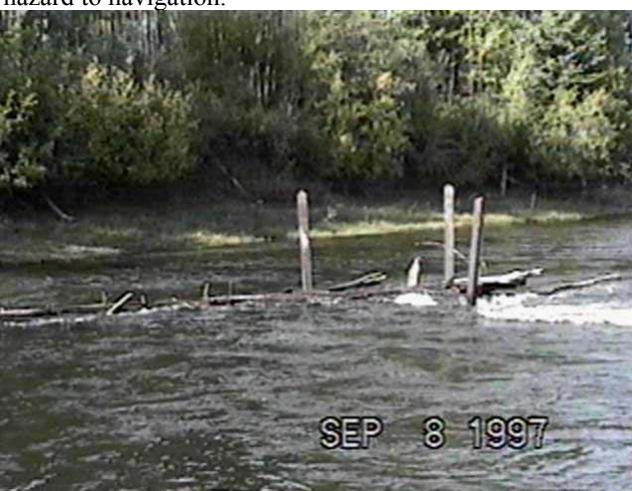
Sept. 8, 1997 – LM82.3 Hand Anchored Sweeper (82.6m³/s)
Constructed in 1991,, this structure generally fails to trap large woody debris, and has deteriorated over time, and been reduced in size.

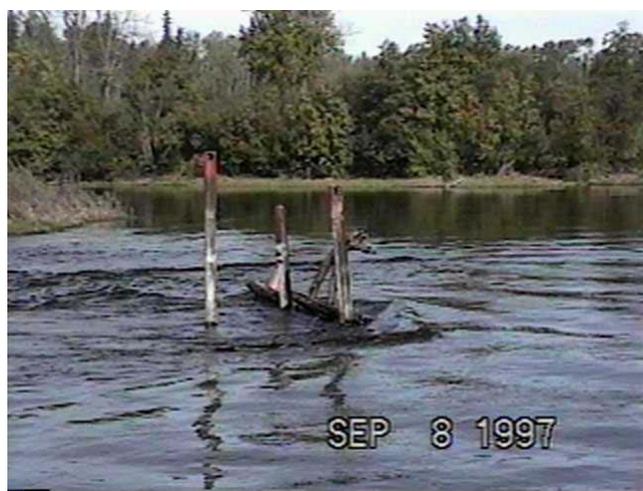
Sept. 8, 1997 – LM 83.0 Rail Debris Catcher (82.6m³/s)
Constructed in 1991 and modified in 1992 with an additional debris boom from the rails to the shore, this structure generally fails to trap woody debris, and is located in an area of very high velocities.

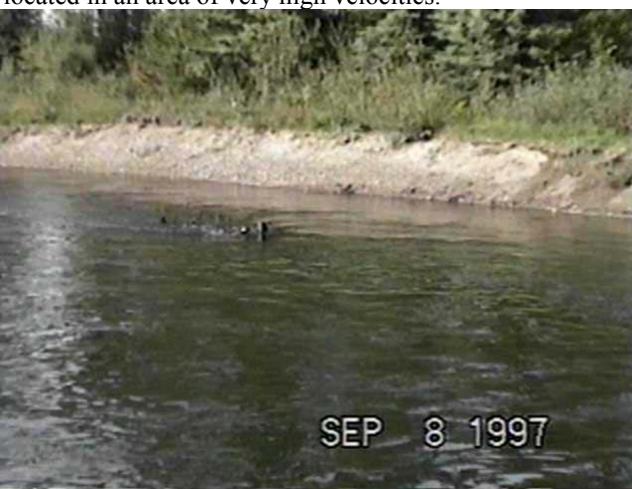
Sept. 8, 1997 – LM 83.0 Rail Debris Catcher (82.6m³/s)
Constructed in 1991 and modified in 1992, this structure generally fails to trap woody debris, and has slowly been reduced in size over time.

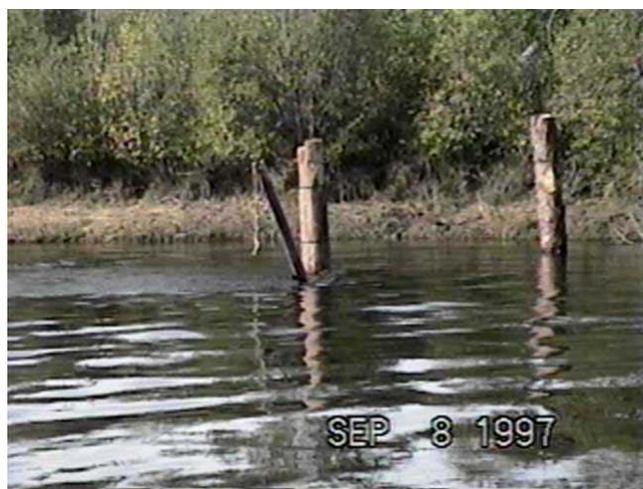
Sept. 8, 1997-LM85.7 Rail Anchored Sweeper (82.6m³/s)
Constructed in 1991, and modified in 1992 and 1993, this structure generally failed to trap large woody debris and the entire sweeper was lost in 1997. The rail has been marked to avoid becoming a hazard to navigation.

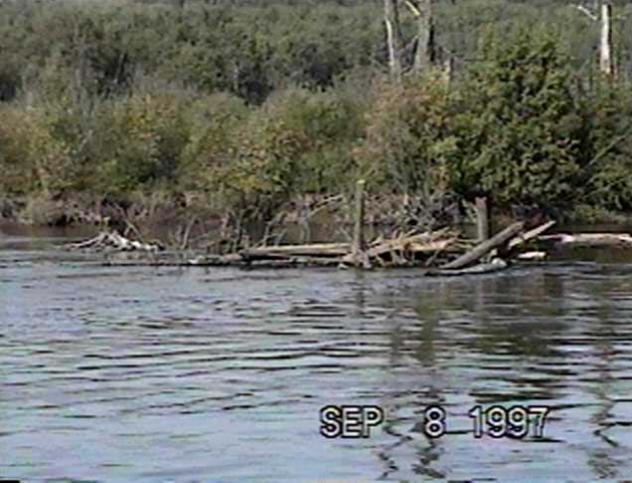
Sept. 8, 1997 – RM86.35 Rail debris Catcher (82.6m³/s)
Constructed in 1991, this structure captured large amounts of material after construction. The shore debris boom was damaged and much of the captured material was lost. The structure now maintains minimal debris.

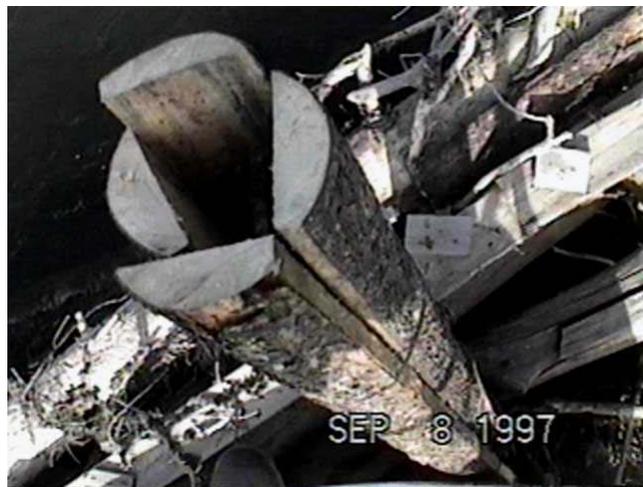
Sept. 8, 1997 – Rail Covers
Rail covers were designed and tested in 1997 to improve the esthetics of habitat complexes by giving the rails the appearance of a natural log. V-Groove and slab rail covers were installed on 10 and 6 rails respectively.
