3695/WP-1429

## Nechako River Habitat Complex Removal (LM 21.4 RDC) Post Construction Monitoring Report

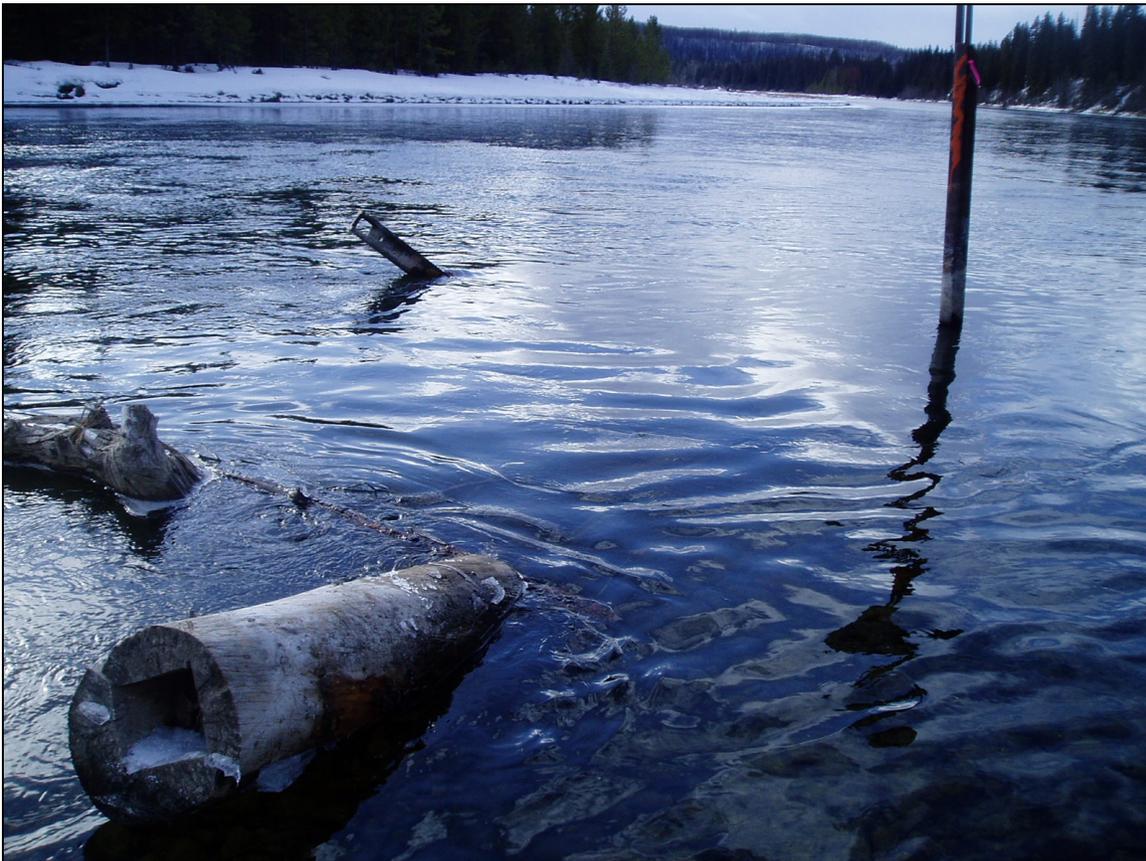
During chinook spawner enumeration flights in the fall of 2005, it was observed that one of the structures (LM21.4) appeared to have failed. A subsequent ground assessment in December of 2005 confirmed that two of the three rails had bent to the point where the tips were just slightly above water level. As such, the Technical Committee of the NFCP agreed that the rails associated with the habitat structure should be removed from the river.

**Plate 1.** Upstream view of the condition of the rail debris catcher on February 22, 2005 prior to being removed. Note the angle of the outer rail and the downstream rail (with wood casing).

The objective of the project was to remove the navigational hazard posed by the bent rails by extracting them from the riverbed. Since the third rail would not function to retain wood independent of the other two and it may eventually become a navigational hazard, it was also planned for removal. Wood associated with the structure was to remain at the site.

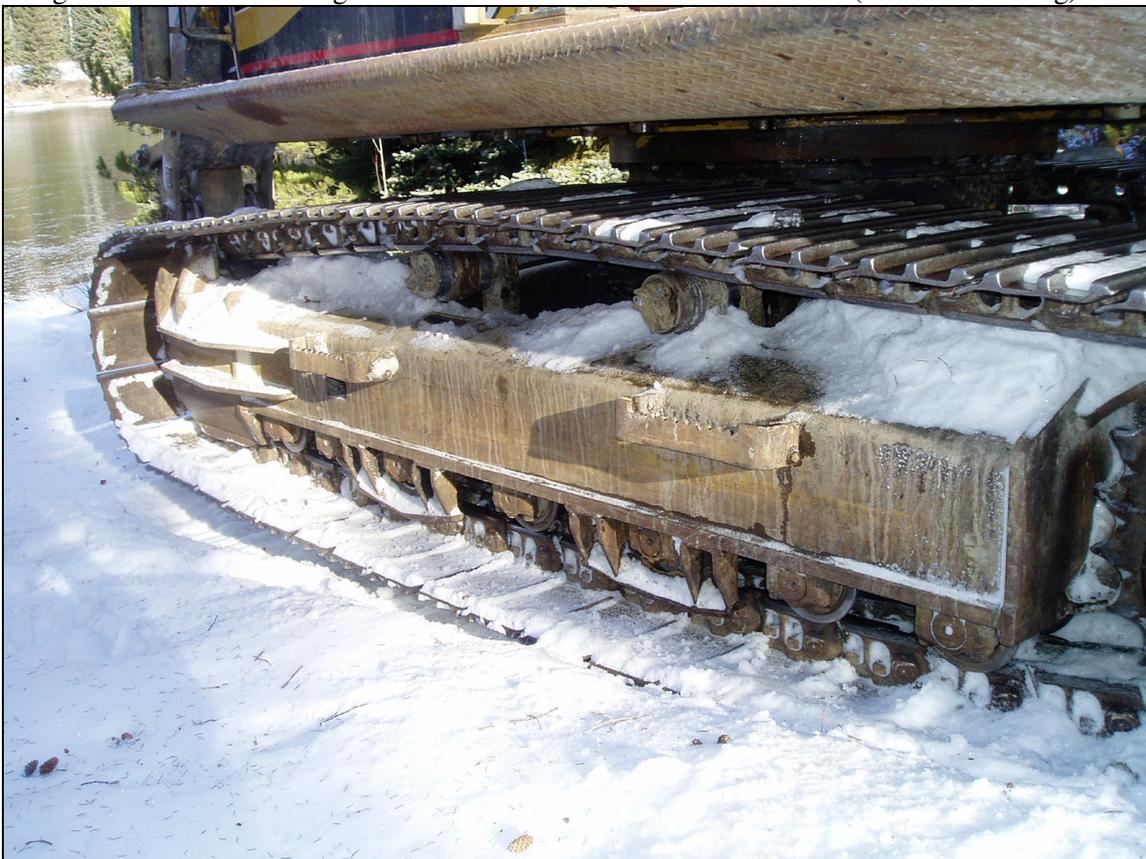
Prior to leaving Prince George the excavator was pressure washed to remove any soil and dirt from the machine (Plate 2). The excavator was walked to the right river bank at the

**Plate 2.** View of the very clean excavator tracks prior to crossing the Nechako River.

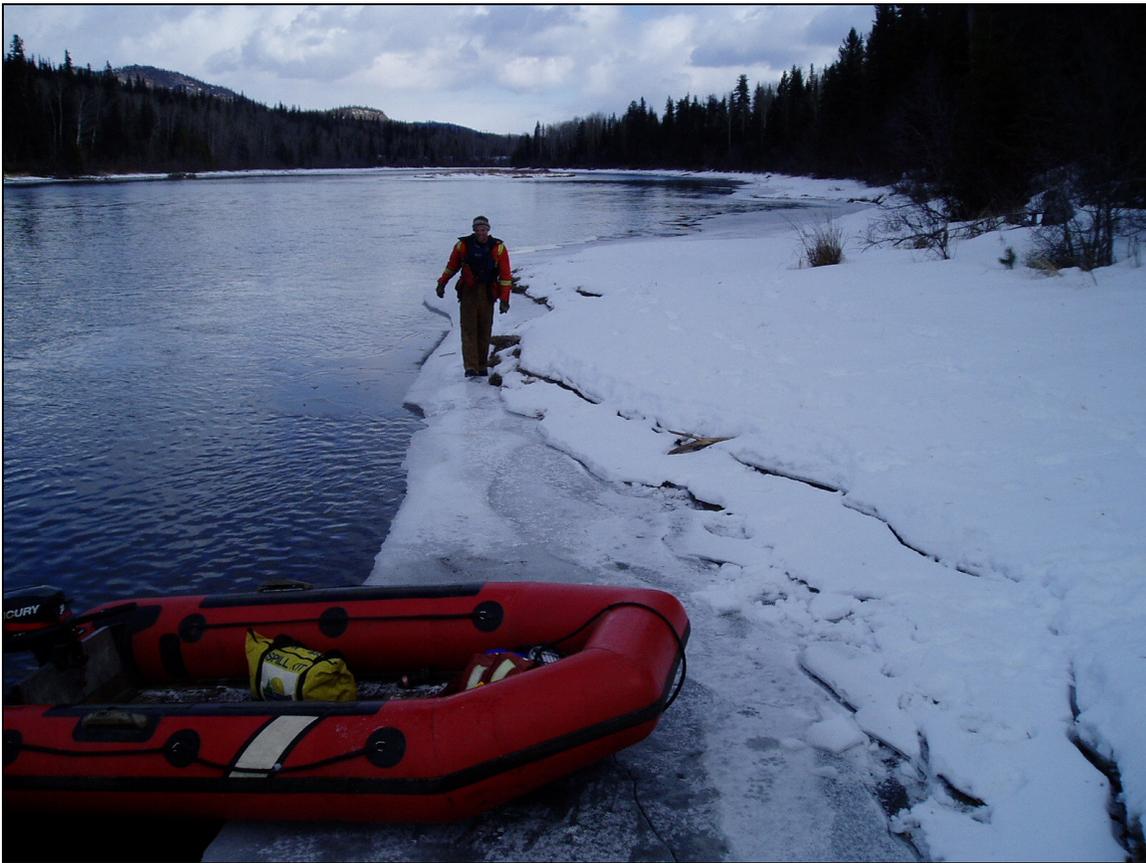
Cutoff Creek Forest Recreation Site boat launch, and then the environmental monitor and excavator operator used an inflatable boat to scout out water depths and look for redds prior to crossing. Since the location that was selected to start the crossing was ten meters downstream of the boat launch, the machine was walked into position down the right bank and turned on the bank prior to entering the water (Plate 3 and 4). No redds were observed at or immediately downstream of the selected crossing location.

**Plate 3.** View of the undisturbed right bank just downstream of the Cutoff Creek Forest Recreation Site boat launch.

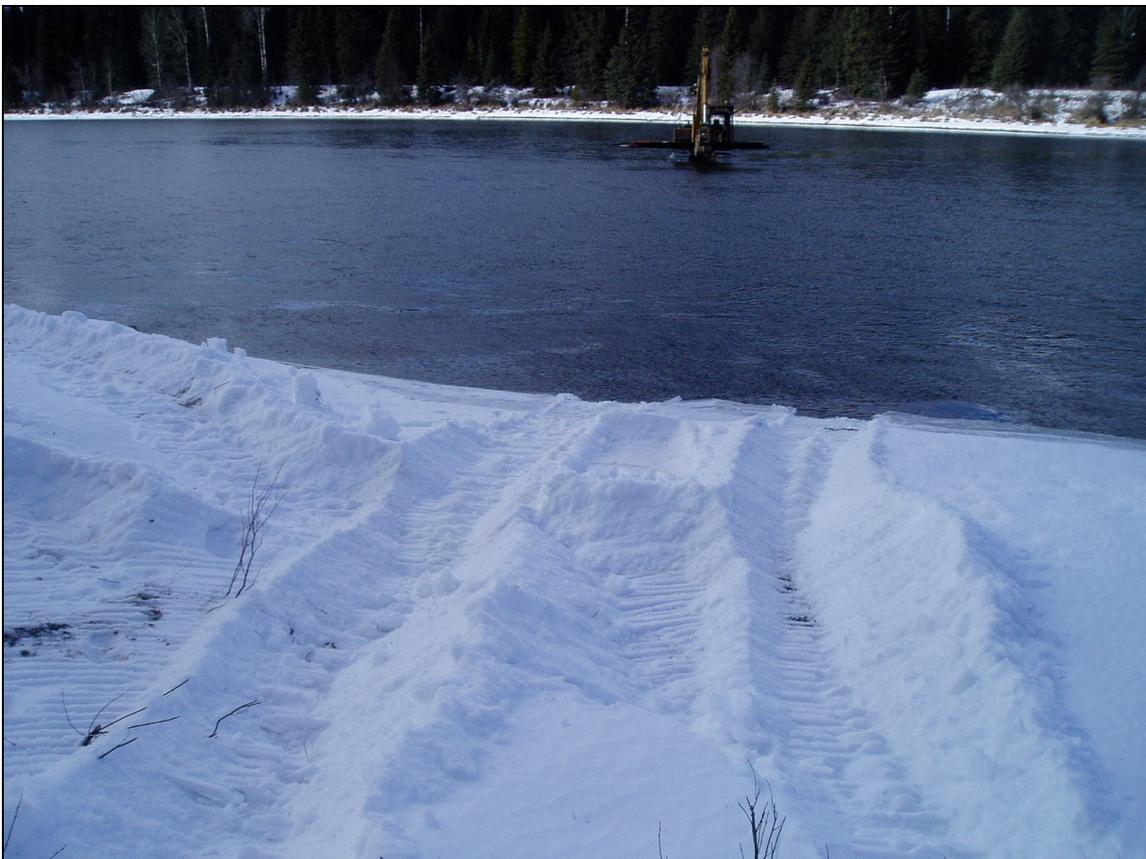
**Plate 4.** View of the undisturbed right bank after the excavator had crossed.

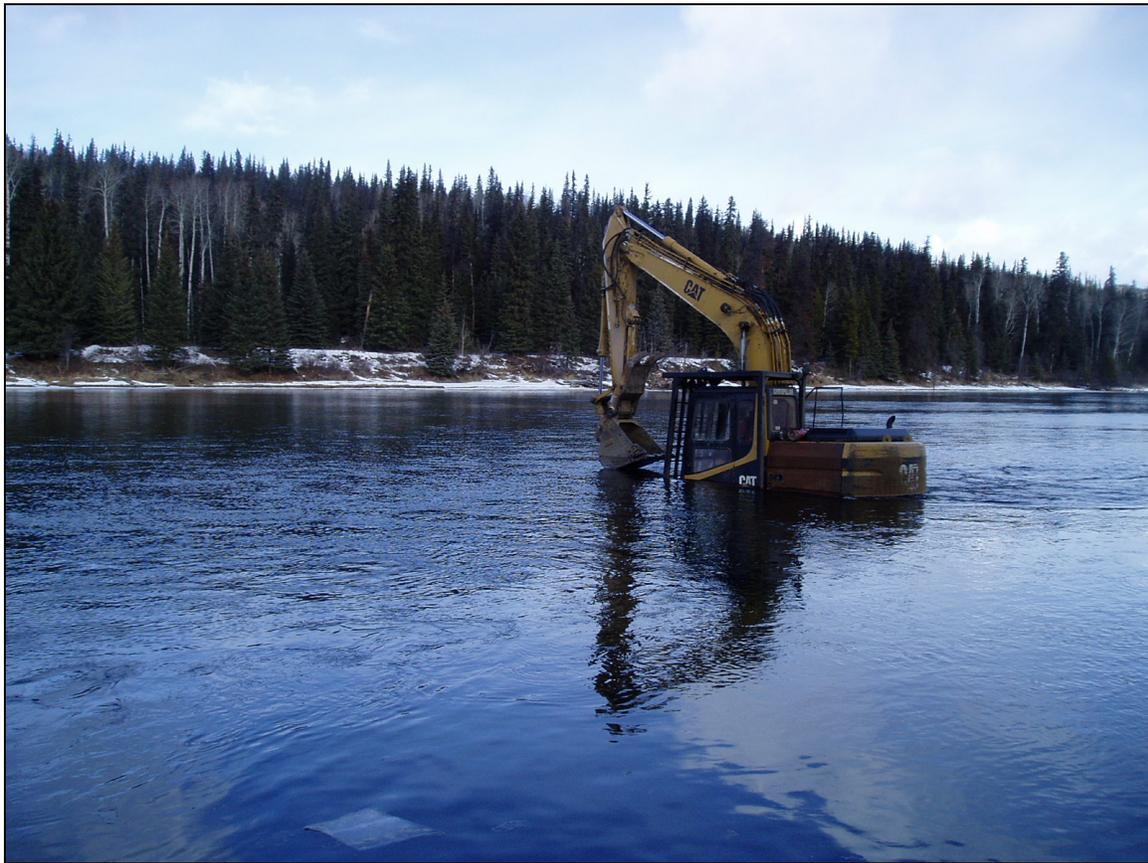
The first 20 to 30 m on the right side of the river was the deepest part of the crossing, with water depths rising to up to the cab of the machine (Plate 5). Moving across the majority of the channel, however, the water was typically only half the depth of the excavator's tracks. Once the left bank was reached the machine exited the water and the tracks were turned upstream. Although shore ice was limited, there was room along the bank between the wetted perimeter and the mature shrubby vegetation for the machine to move upstream for approximately 1 km to the job site (Plate 6).

**Plate 5.** View of the excavator crossing the Nechako River at the deepest location.

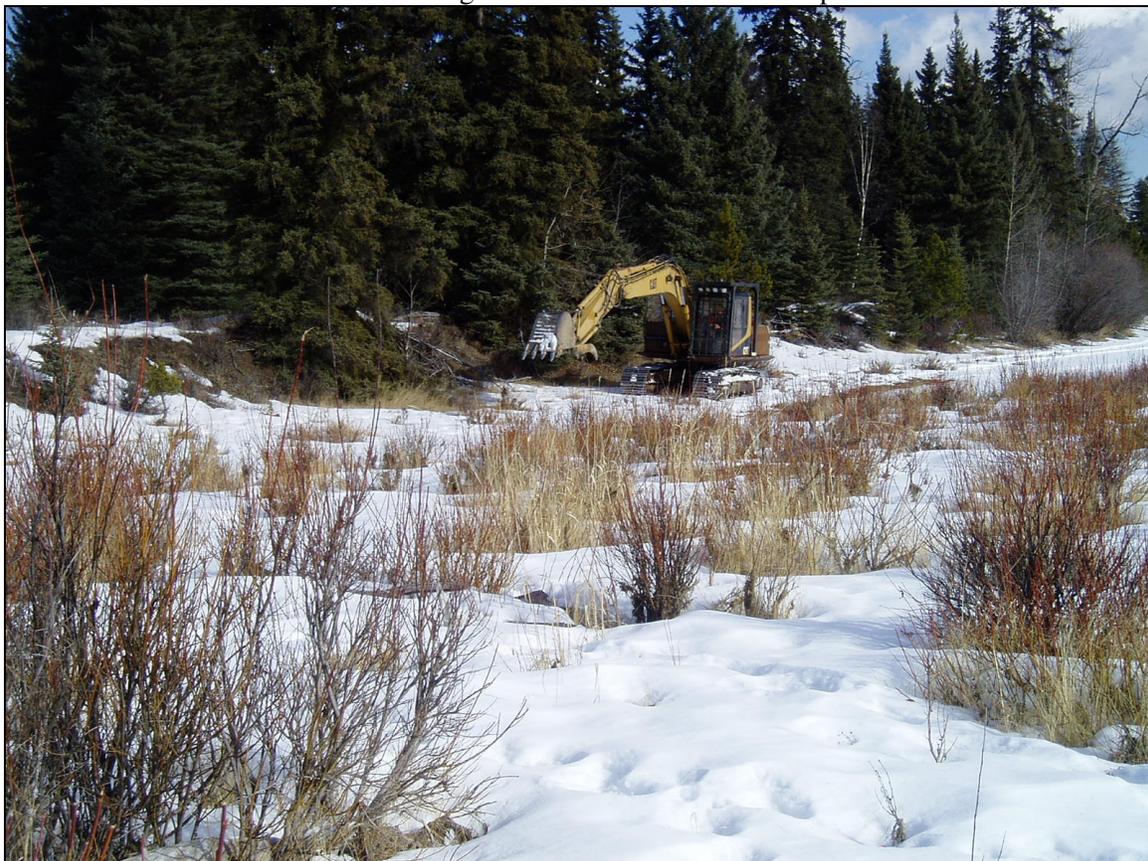
**Plate 6.** View of the excavator walking up the right bank of the Nechako River toward the LM 21.4 RDC.

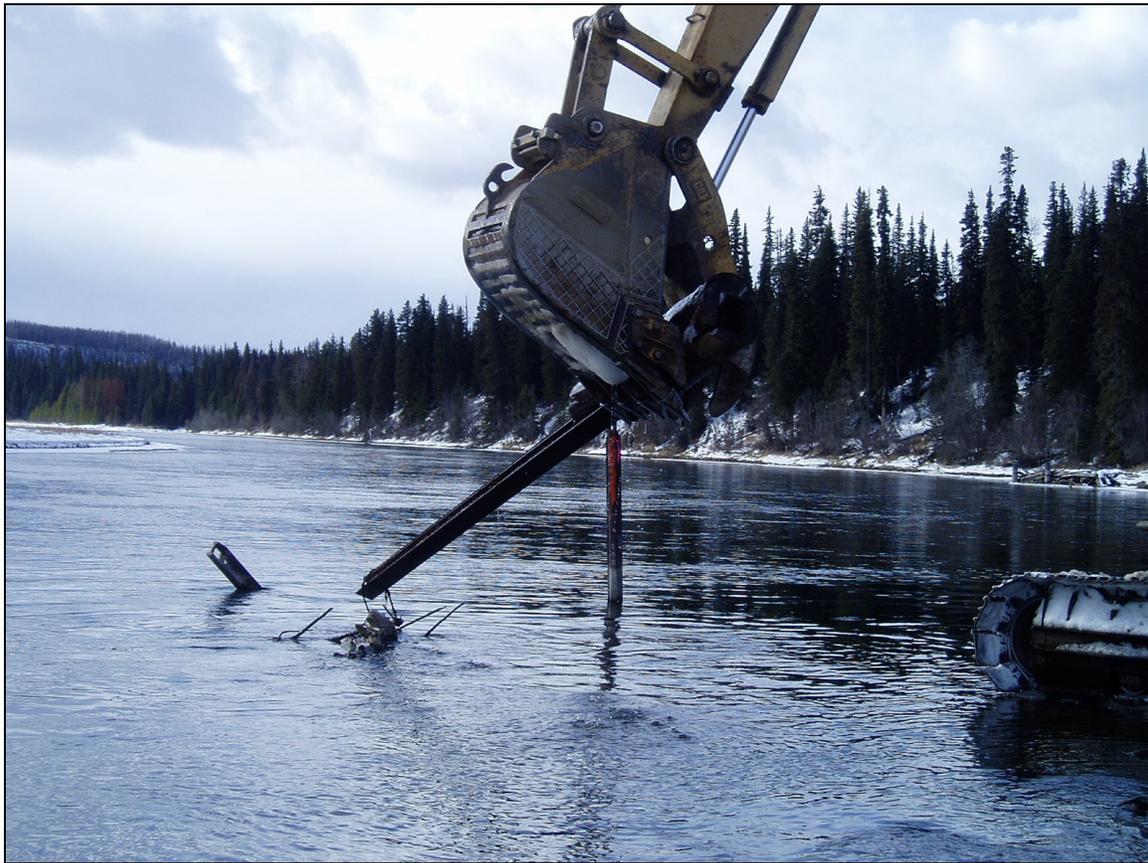
**Plate 7.** View of the failing downstream rail with the wooden top casing being removed.

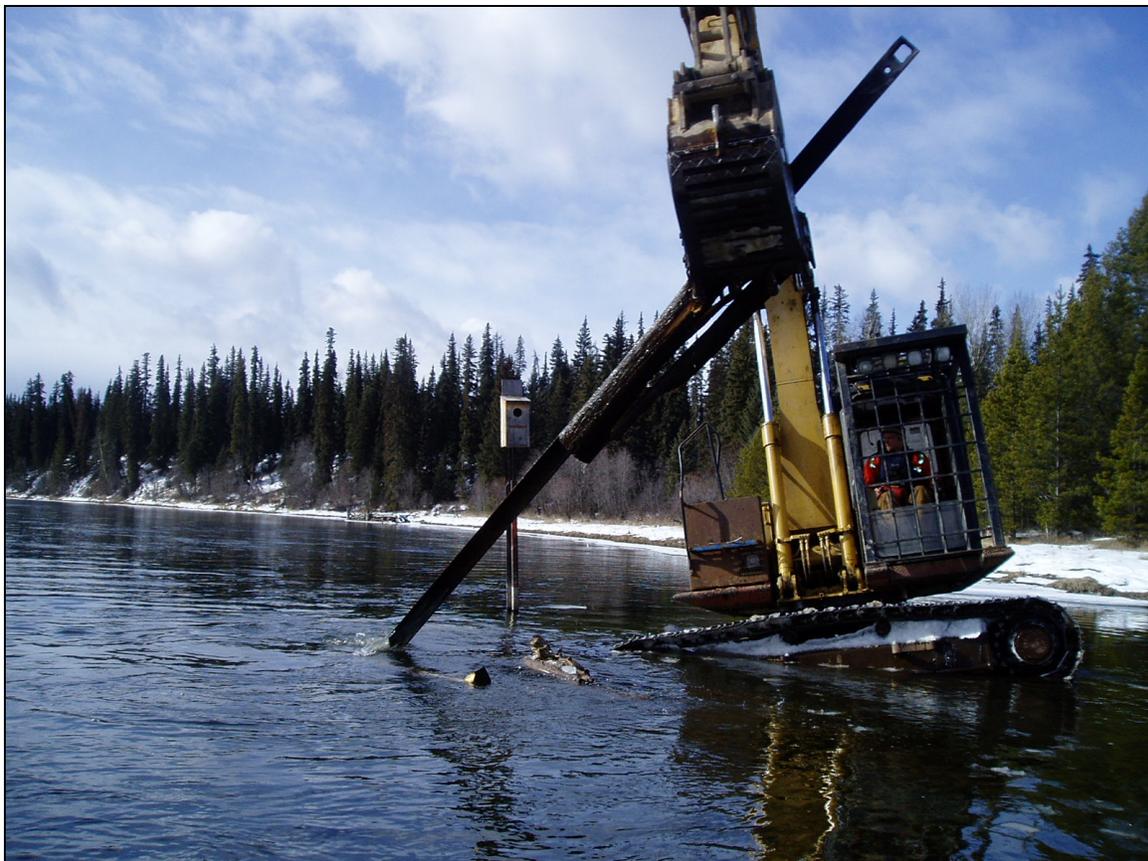
**Plate 8.** View of the failing rail that was furthest from shore being removed.

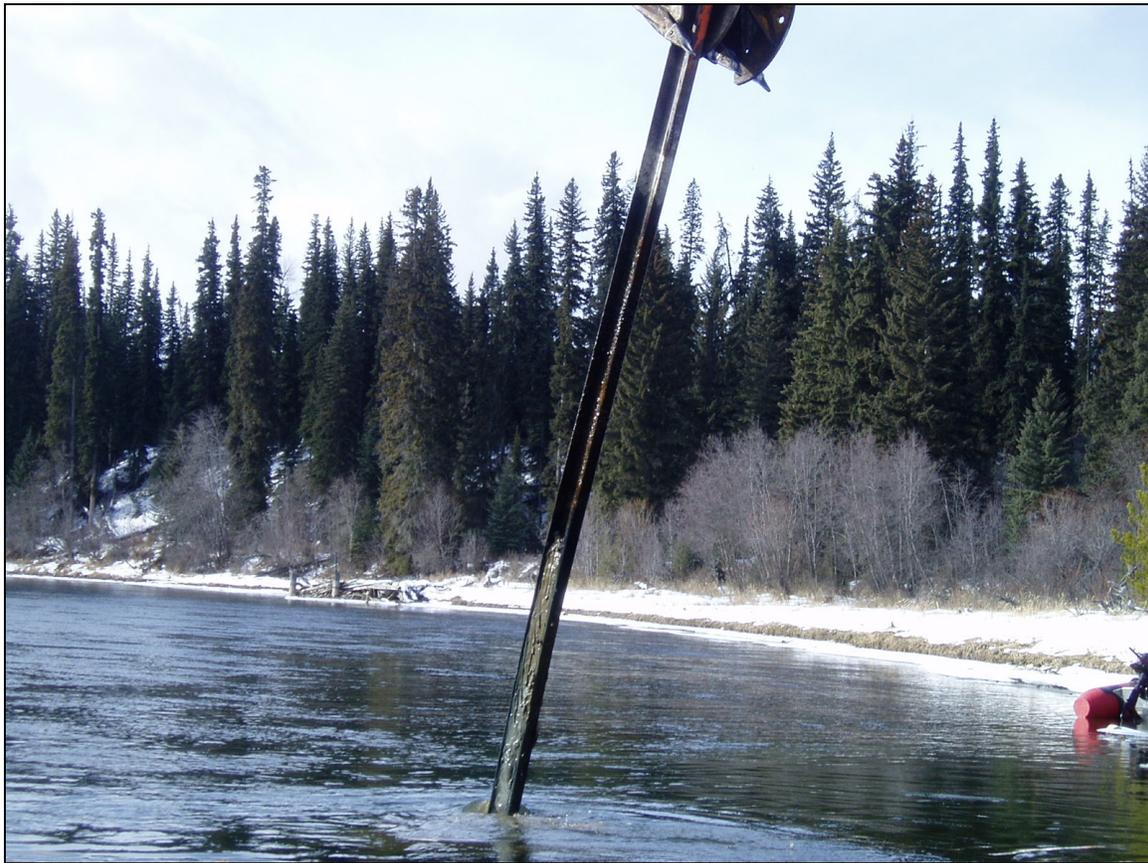
**Plate 9.** View of the last rail with the bird box attached being removed.

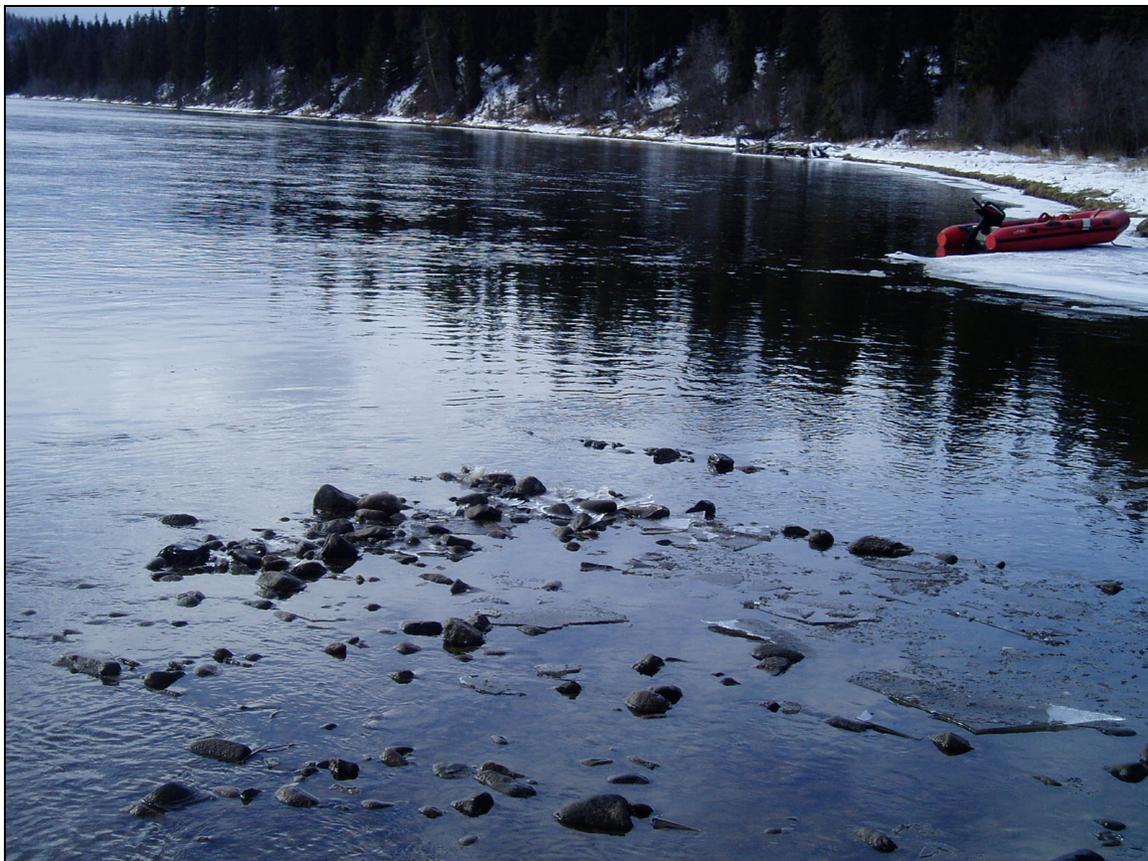
While the water level had decreased by approximately 40 cm since the previous site visit in December of 2005, this was not sufficient to completely dewater the shallow gravel bar just downstream of the scour pool created by the RDC structure. For that reason the machine needed to enter the water in order to get proper leverage for removing the rails. The downstream rail with the wooden casing on top was removed first, followed by the leaning rail that was furthest from the left bank, and then the upright rail with the bird box attached (Plates 7, 8, and 9). In all cases the excavator was able to easily extract the rails using the bucket with thumb attachment (Plate 10).

**Plate 10.** View of the project area after the instream works had been completed.
