IN-STREAM HABITAT COMPLEXING
1988-1990
- PILOT TESTING -

NECHAKO FISHERIES CONSERVATION PROGRAM
Technical Report No. RM90-3

Prepared by:
Triton Environmental Consultants Ltd.
April 1996

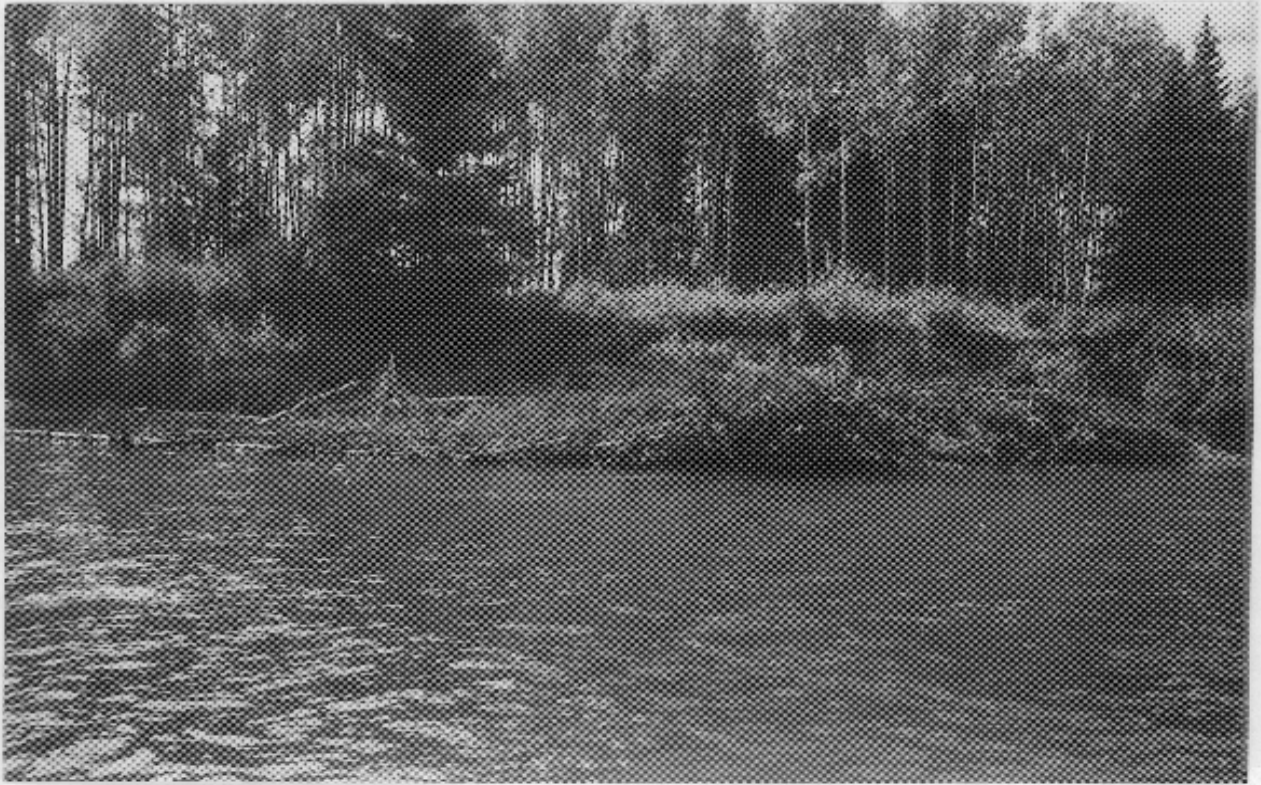
Photo 1: Rootwad Sweeper (RM30.7RS) Shifted Downstream by Magnitude of Summer Cooling Flows

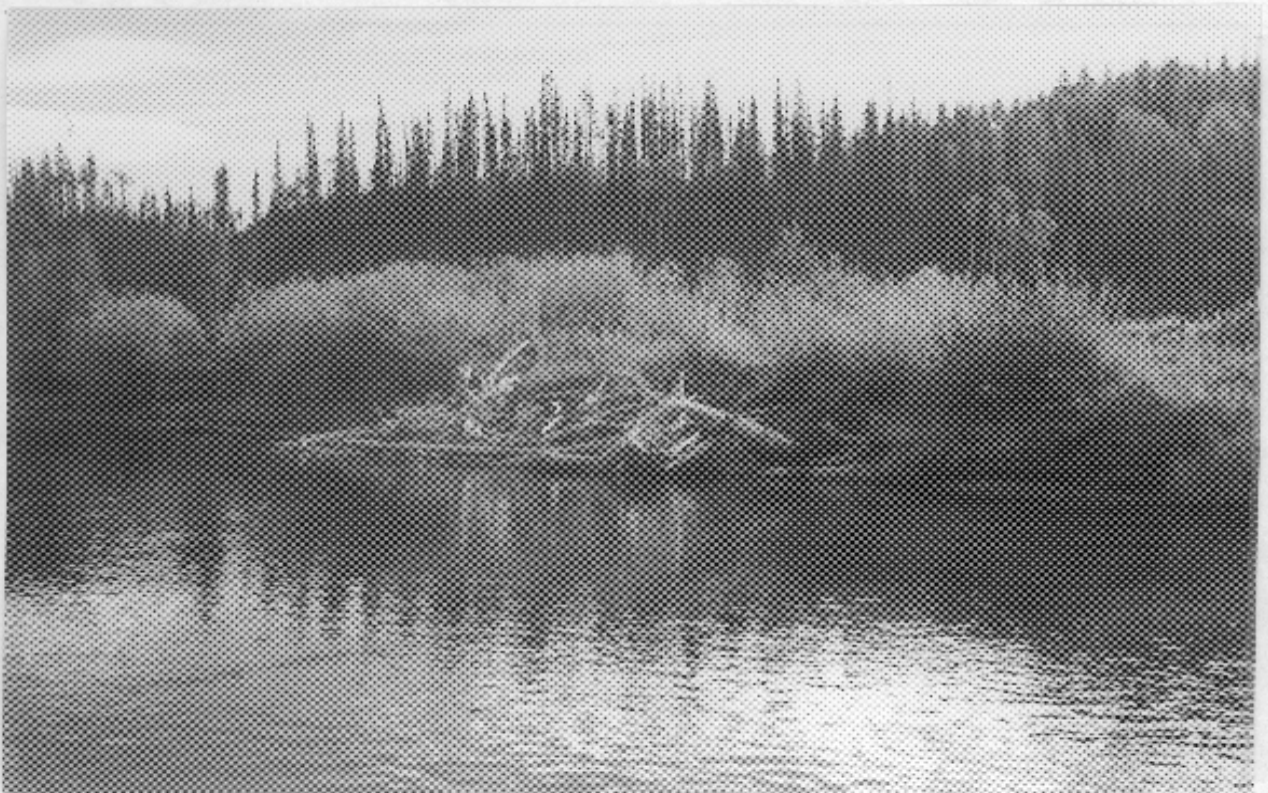
Photo 2: Brush Pile (RM31.4BP) Structure Sound

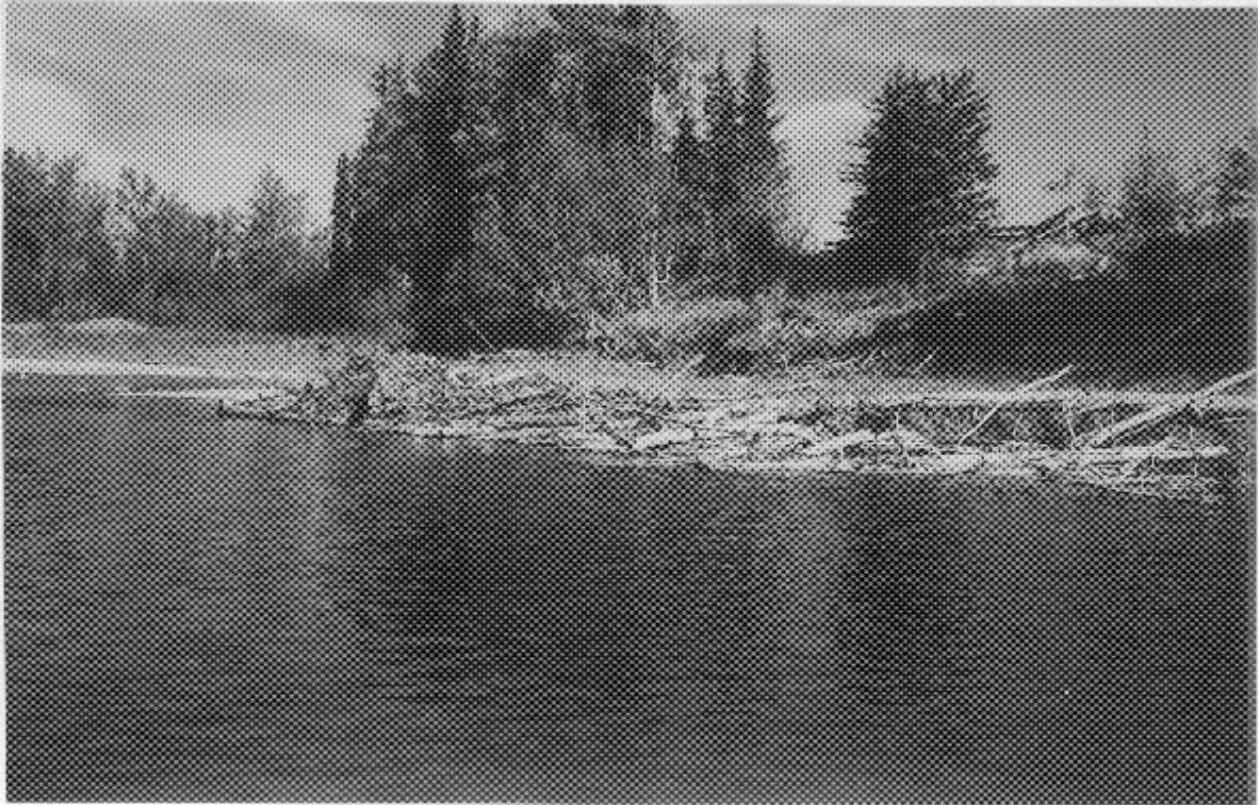
Photo 3: Floating Crib (RM27.4FC) Structure Sound

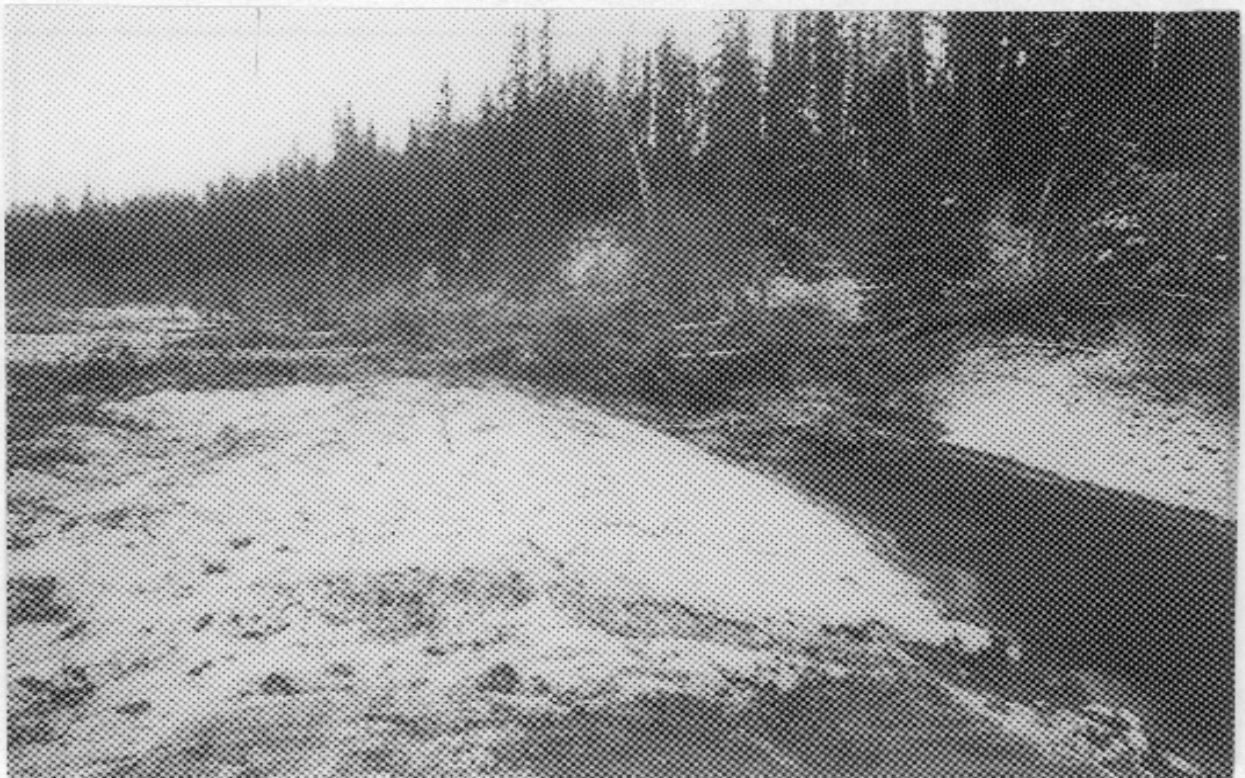
Photo 6: Side Channel Habitat Complex Test Section (1988)
(Note density of full spanning structure and subsequent flow reduction in channel.)

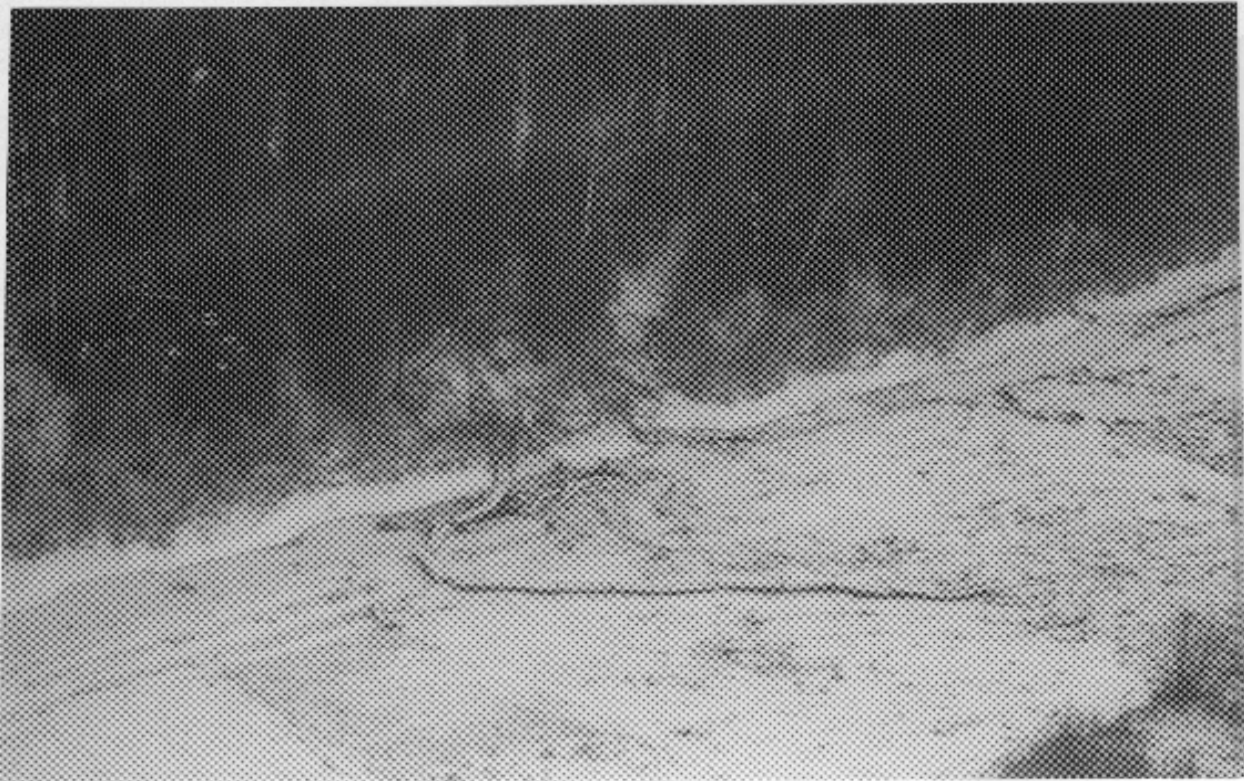
Photo 7: Aerial View of Side Channel Debris Boom (1988)
(Note full spanning structure and upstream debris retention in channel.)

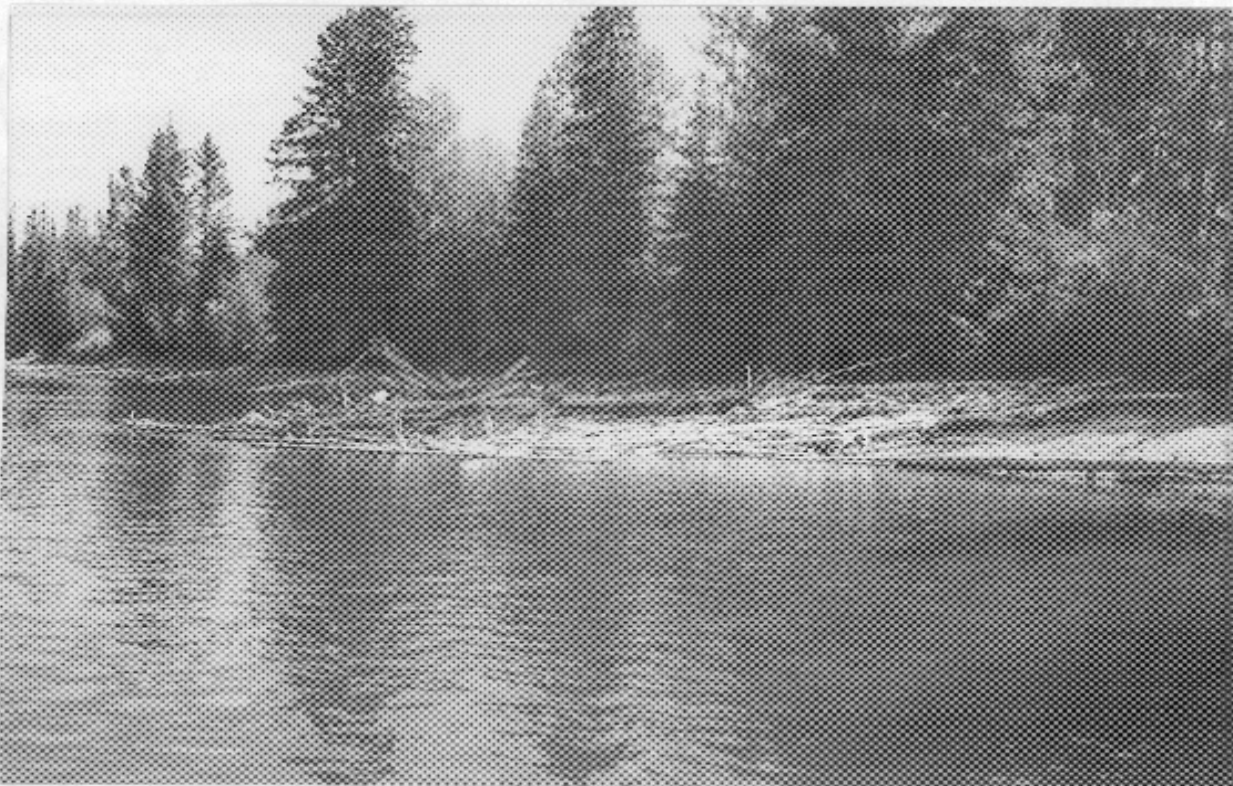
Photo 8: Pseudo Beaver Lodge (RM24.6PBL) Showing Significant Amount of Debris Collected During Cooling Flows

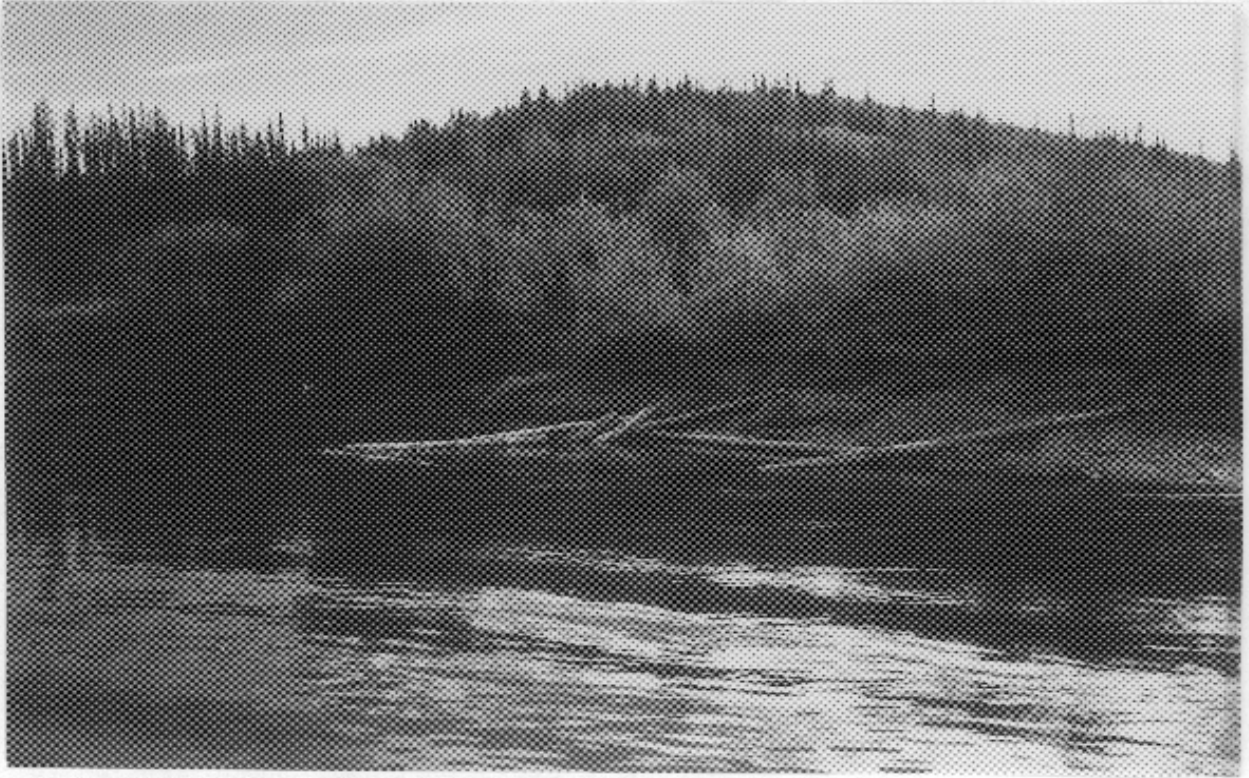
The 7 pseudo beaver lodges constructed during the spring of 1989 experienced stability problems as flows receded. During high flows the complex would shift position. As flows dropped, the stiff-legs would get hung up on the bank and cause the offshore end of the complex to become submerged, resulting in the loss of seeded debris. The recommendation was to modify the stiff-leg anchoring system and re-seed the complexes with debris.

Photo 9: Pseudo Beaver Lodge (RM31.1PBL) Shown Stranded on Shore With Debris Lost Following Lowered Water Level

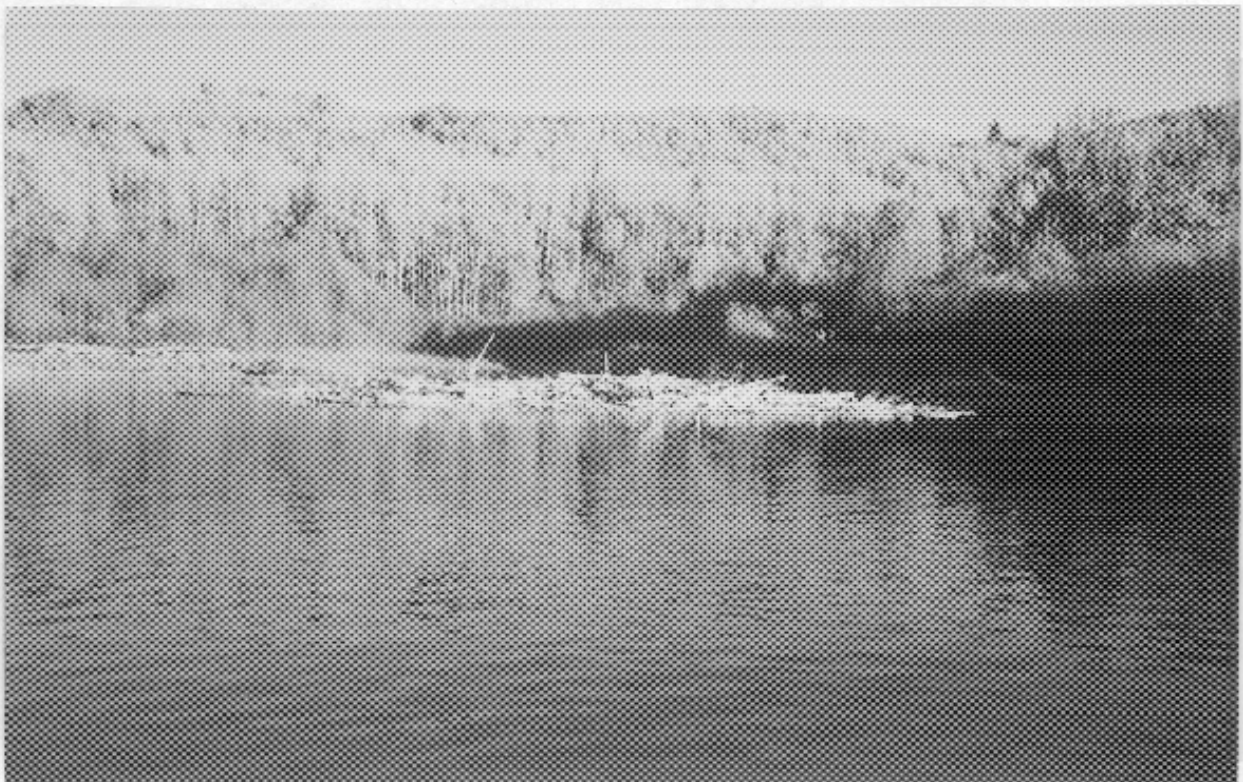
The 2 pipe-pile debris catchers entrapped significant debris with the only damage being that the offshore piling on both complexes had become bent and was leaning downstream at 15 to 20 degrees. No repairs were recommended.

Photo 10: Pipe Pile Debris Catcher (RM35.4PDC) Demonstrating Significant Debris Entrapment

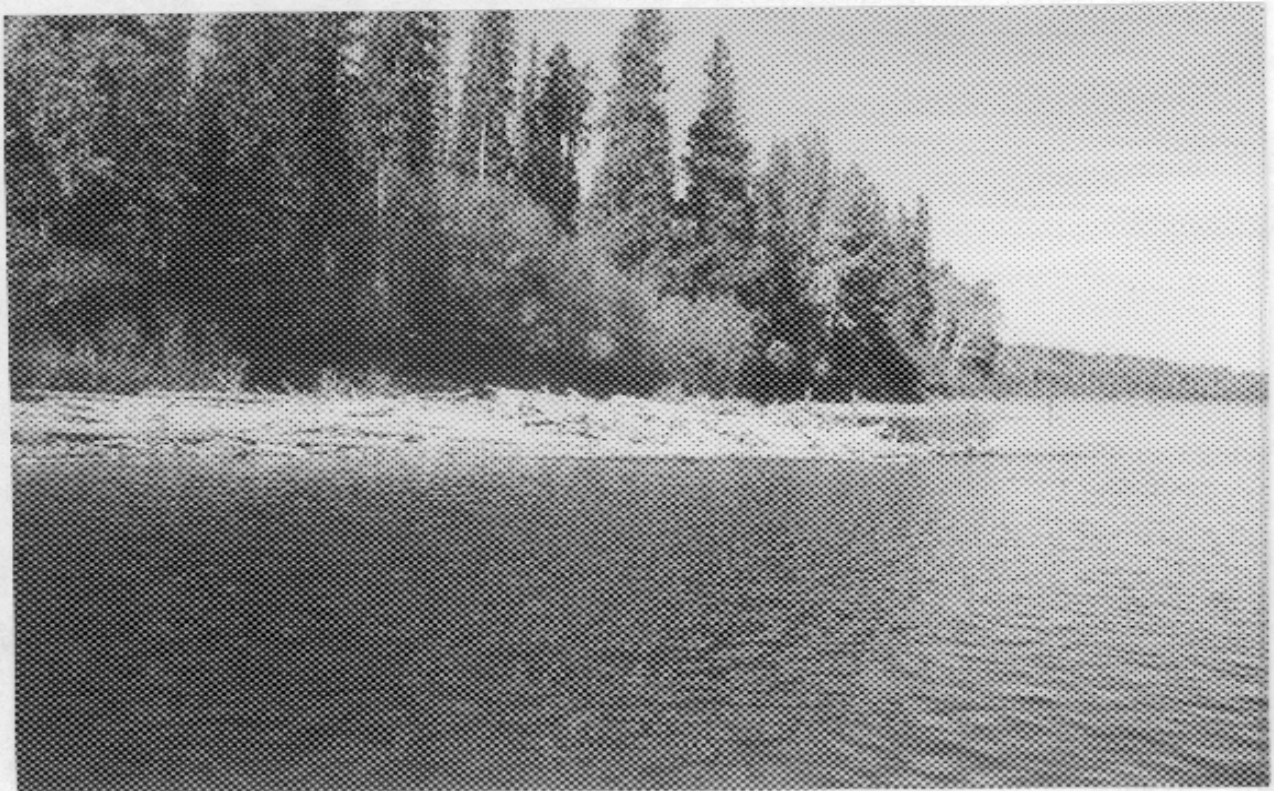
Photo 14: Rail Debris Catcher (LM22.6RDC) Demonstrating Significant Debris Entrapment Following Cooling Flows

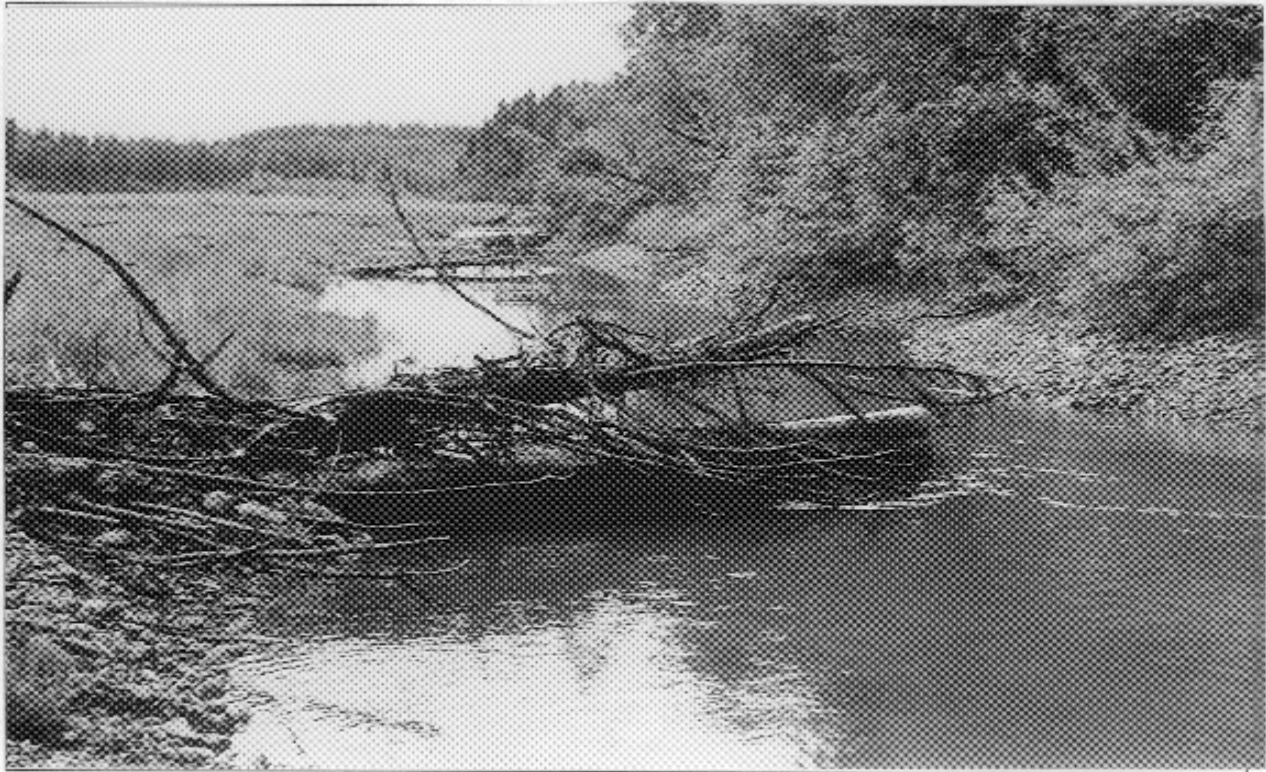
Photo 15: Modified Side Channel Habitat Complexes (1990)
(Note partially spanning single tree angled downstream and cover debris cabled at margin reducing amount of debris entrapment and resulting in increased velocities.)

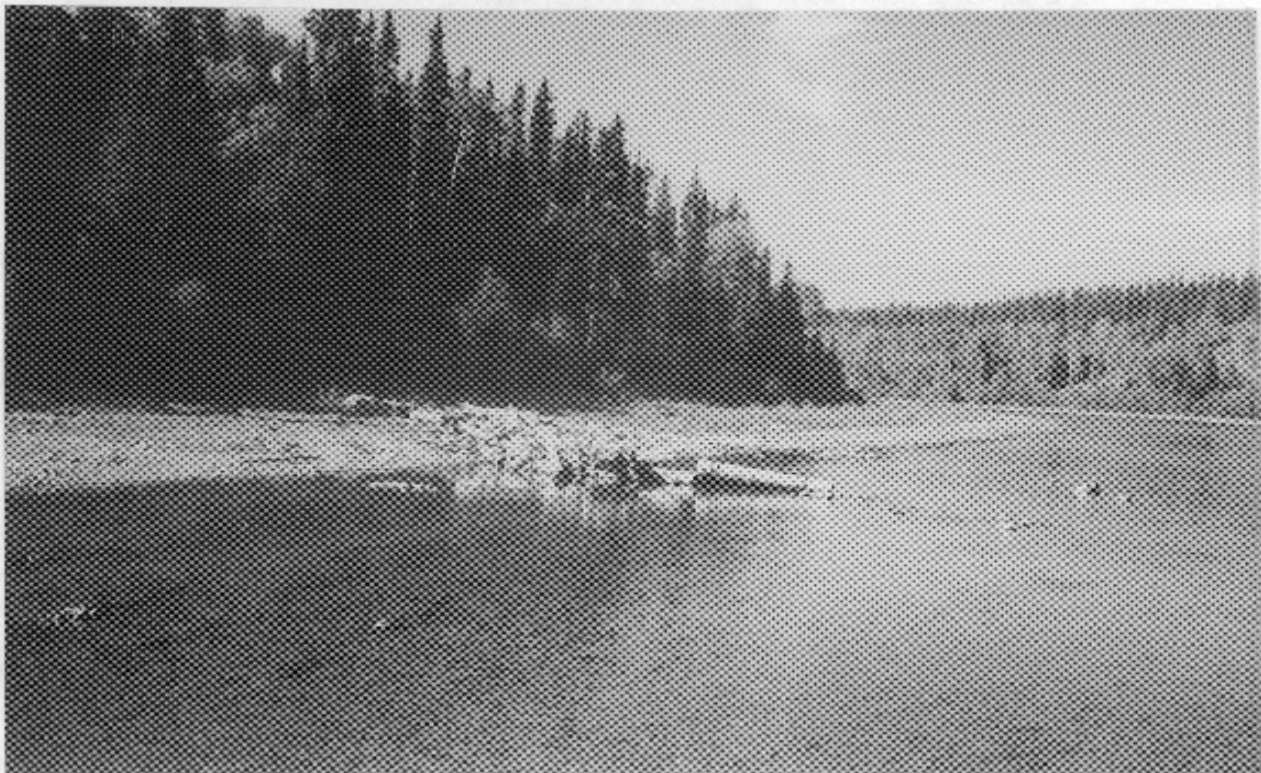
Photo 16: Relocated Side Channel Debris Boom (1990) Following 1990 Summer Cooling Flows (Structure was relocated upstream of side channel entrance to divert floating debris from entering side channel.)
