**IN-STREAM HABITAT COMPLEXING,
1997**

- Pilot Testing -

*NECHAKO FISHERIES CONSERVATION PROGRAM
Technical Report No. RM97-2*

Prepared by:
Triton Environmental Consultants Ltd.
January 2003

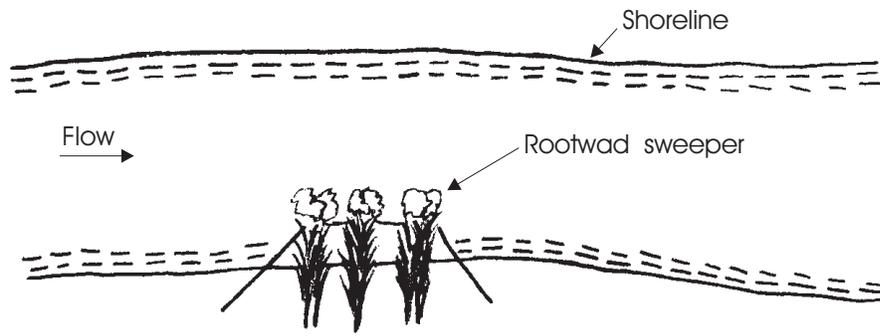
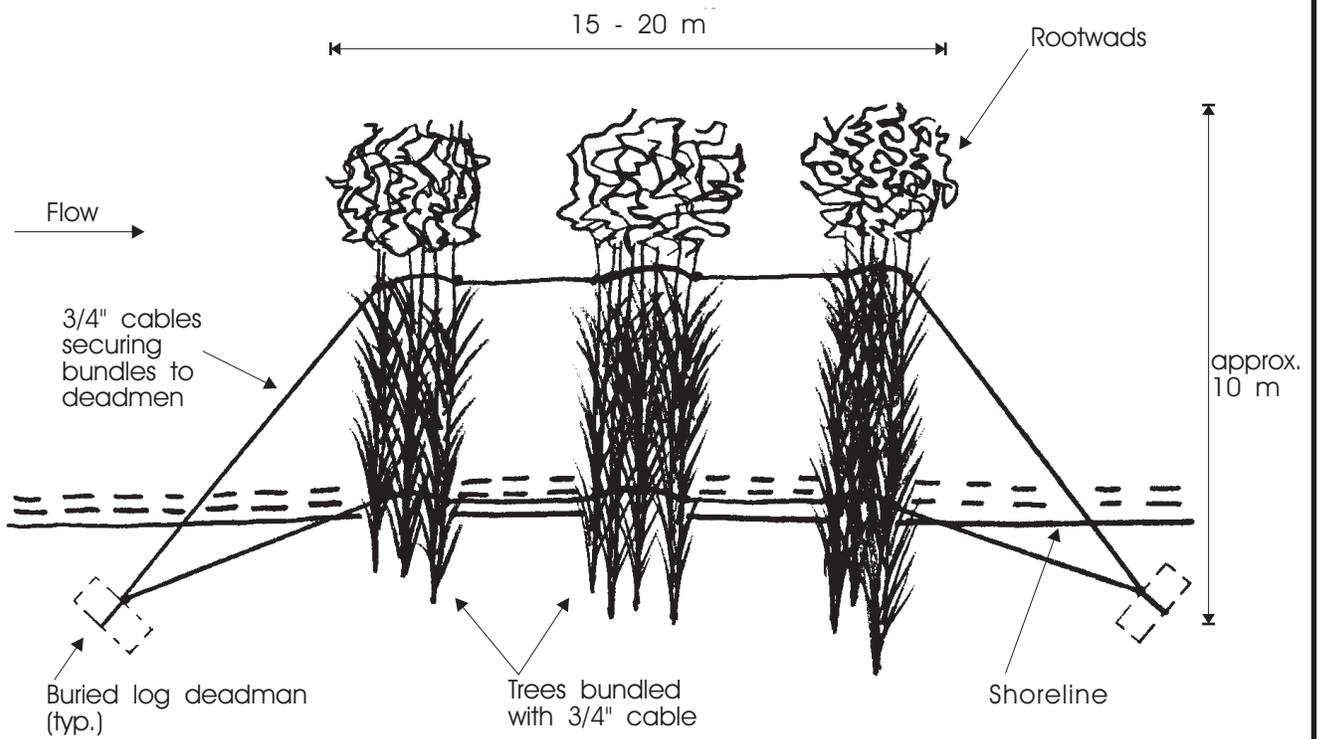
FIGURE 1. ROOT WAD SWEEPER (1988)

The last remaining rootwad sweeper complex from the original four complexes constructed in 1988 had been modified in 1990 to reduce seeded material. Since then, this complex has remained stable, with no damage or displacement noted. No modification was recommended as it was performing satisfactorily.

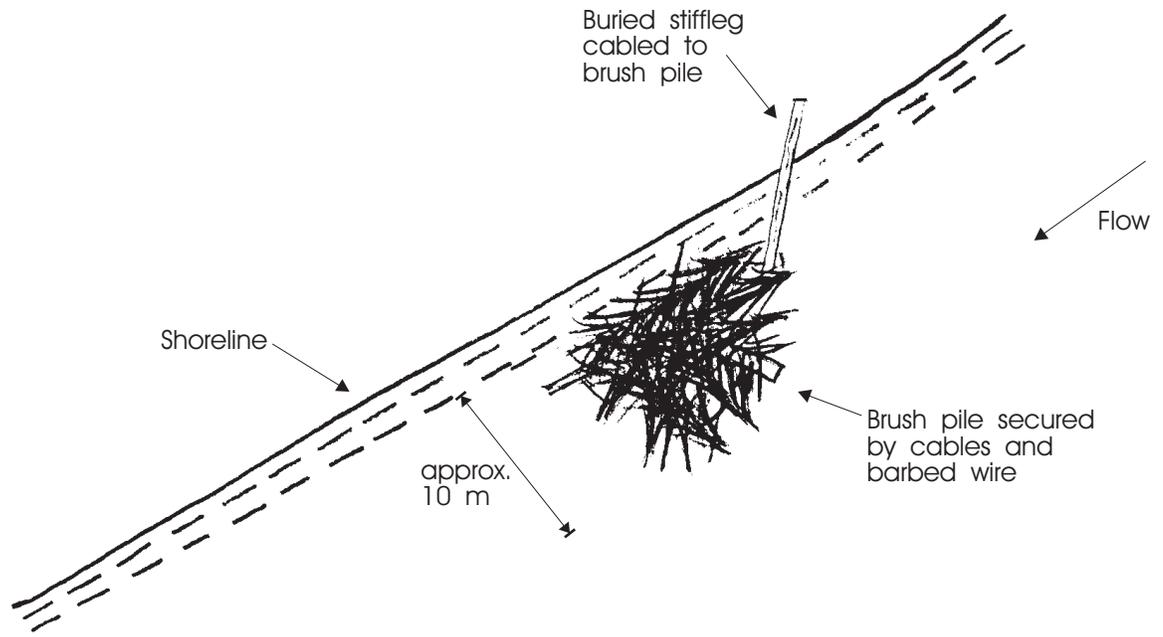
FIGURE 2. MAINSTEM BRUSH PILE (1988)

The brush pile complex installed in 1988 has remained stable. However, cover area has decreased from a high of 37 m² in the spring of 1991 to 1 m² in the fall of 1997. Due to its lack of cover area and the continued degradation of this complex the structure has been recommended for removal from further assessment.

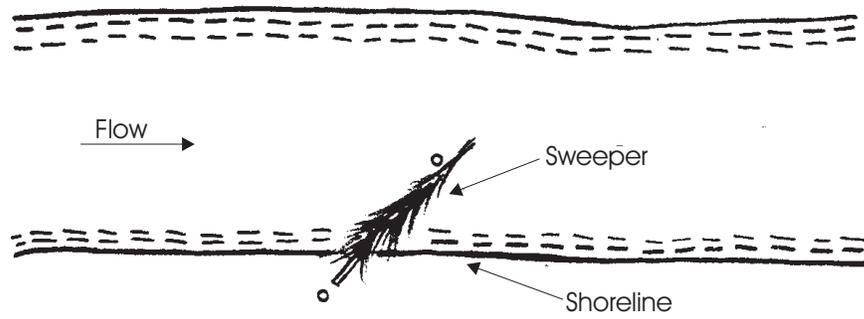
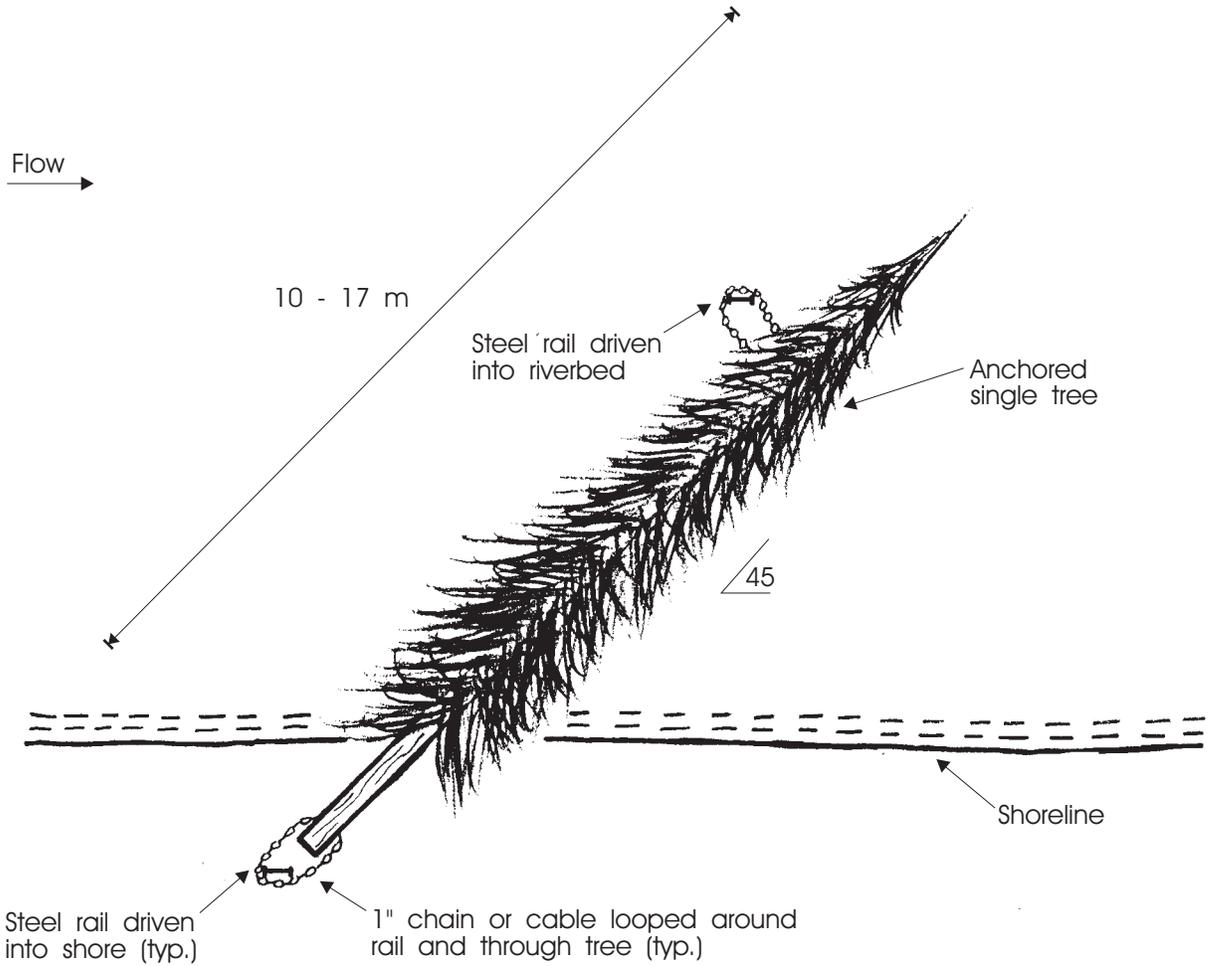
FIGURE 5. RAIL-ANCHORED SWEEPER (1991)

Rail Anchored Sweepers	RAS	9	Detached from rails and displaced - RM22.1RAS, RM22.9RAS, RM26.9RAS, RM82.1RAS, LM82.2RAS and RM85.7RAS	0 - 6	Reduced from 1996	No	Gravel, cobble, with fines and boulders at some complexes.	Continued defoliation of all structures resulted in reduction in cover areas.	Remove 3 structures, repair or remove 6 remaining structures due to continued defoliation and failure to trap new debris.
Hand-Placed Anchored Sweepers	HAS	7	Shifted to shore - LM32.65HAS, Lost sweeper - LM80.2HAS	0 - 4	Reduced from 1996	No	Gravel, cobble, fines		Add downstream boom to LM32.65HAS to place into current. Remove LM80.2HAS due to complete loss of the structure
Emergent Fry Structures	EFS	2	No fall assessment due to high flows. In spring 1997, both structures were almost completely defoliated.	Not available	-	Not available	Not available	Some of the rebar anchors were lifted by ice.	None

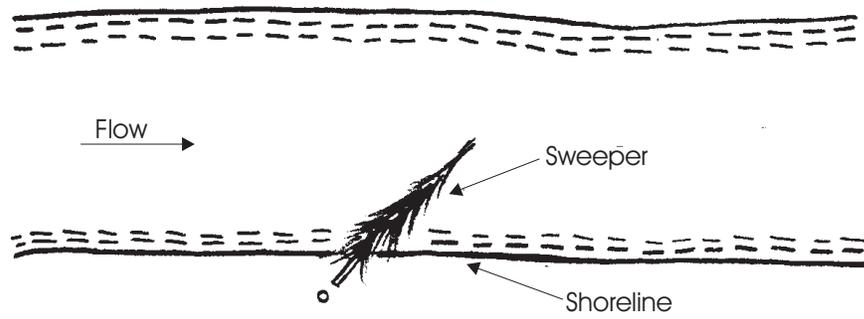
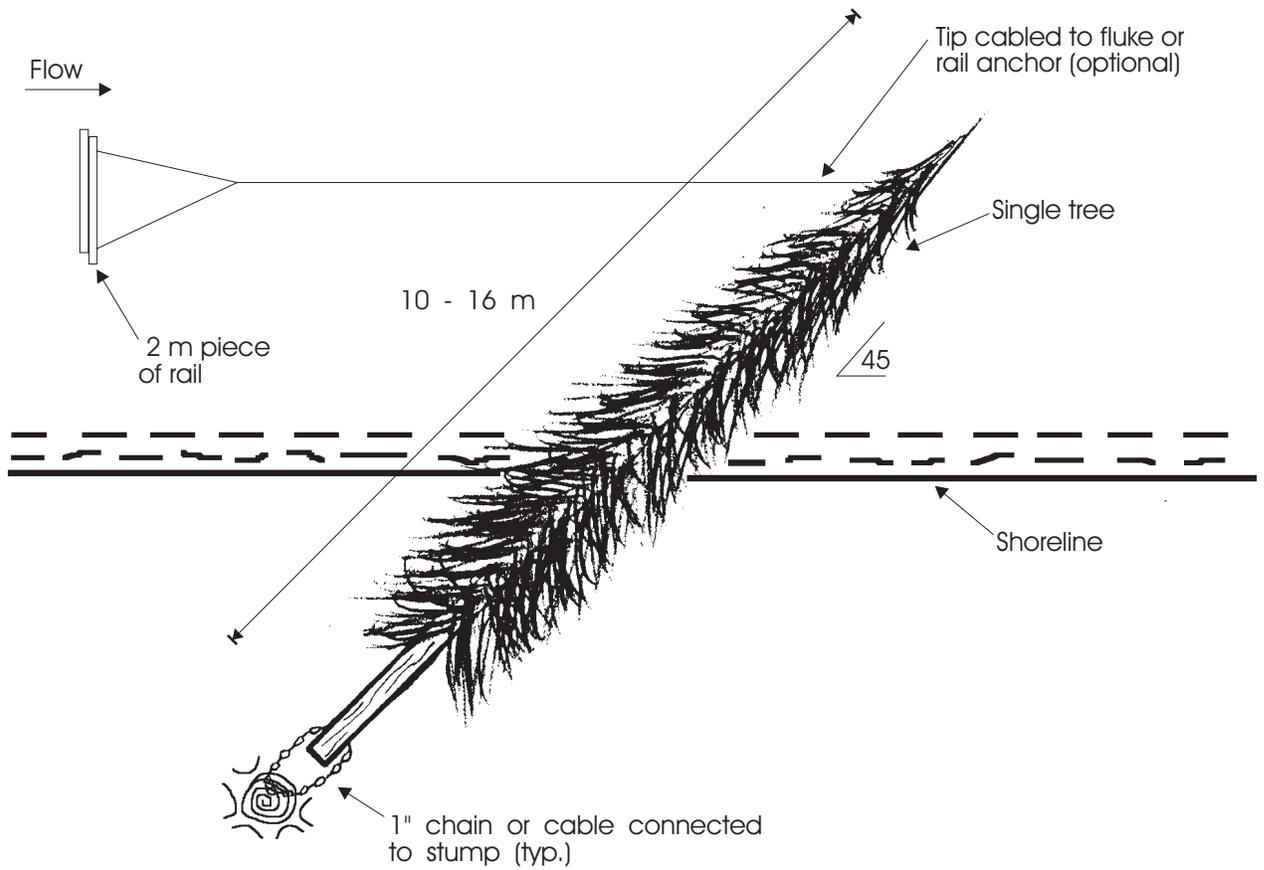
FIGURE 7. HAND-PLACED ANCHORED SWEEPER (1991)

During 1997, one hand-placed anchored sweeper was damaged and another displaced. These structures were recommended for removal and repair, respectively.

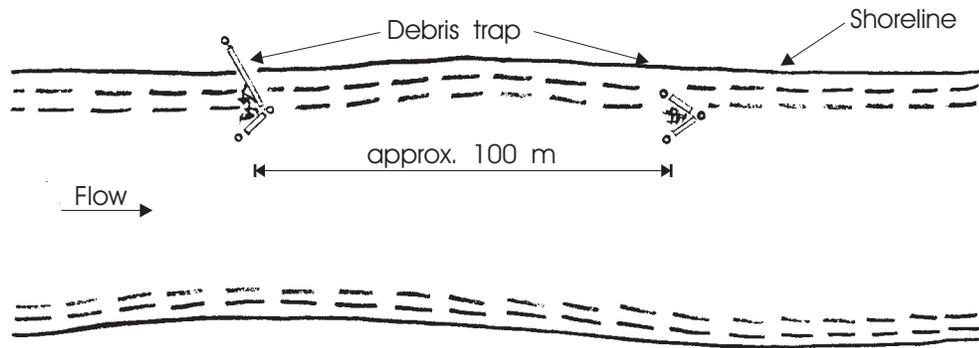
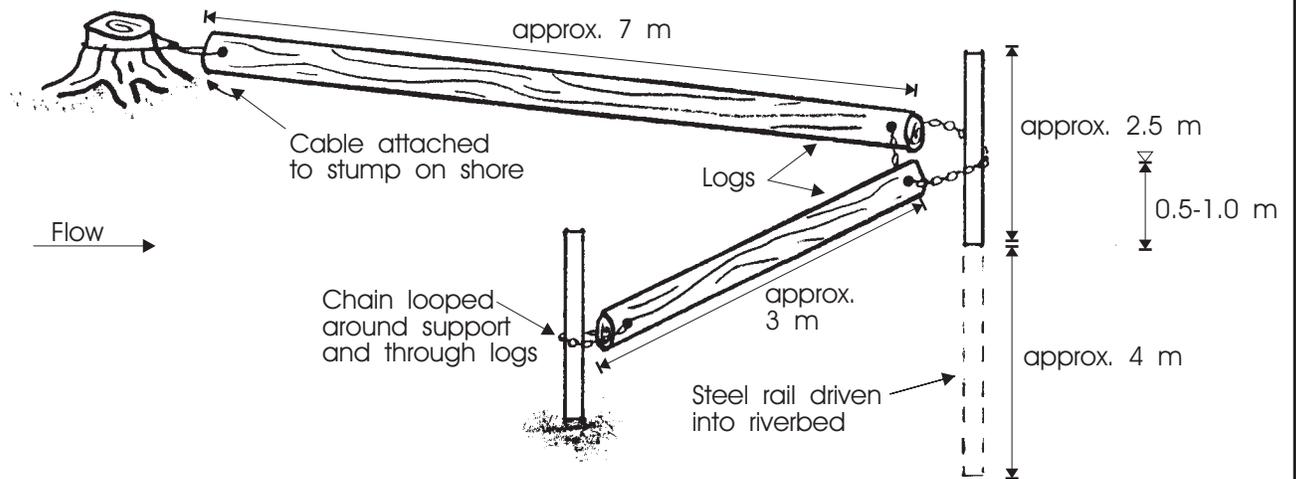
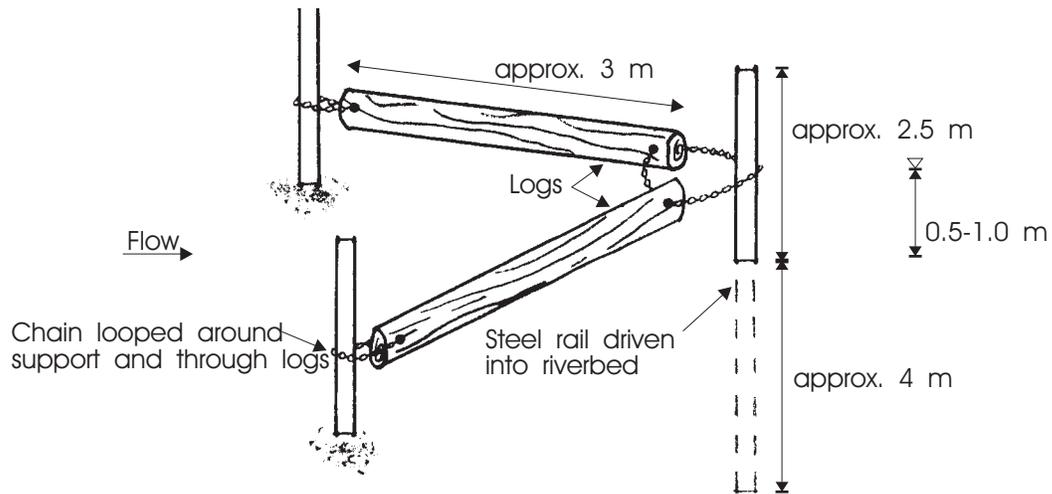
FIGURE 10. RAIL DEBRIS CATCHER (1990)

The majority of the debris catchers lost debris in 1997. None of the pipe-pile debris catchers were damaged in 1997, but six of the rail debris catchers had their rails lifted by ice, had their rails tipped over, or had a shore boom broken.

All of the rails of RM25.4RDC were bent at various angles, and the structure lost all of its debris. Two structures had their rails lifted by ice movements (RM29.3RDC, MC85.6RDC). Three other structures (RM16.5RDC, RM16.8RDC, and RM22.0RDC) suffered damage to their shore booms, causing a loss of seeded material and failure to trap new debris. Sedimentation was found behind 12 sites, and erosion was observed at 11 sites. Large cover areas and positions in the river resulted in low velocities through some of the complexes, with flow passing outside of them.

Two pipe-piles that had failed on the small complex RM34.7PDC in 1995 were recommended for removal because of the potential navigational hazard they represented as they rested just below the water surface at low flows. Five rail debris catchers were recommended for repair, two were recommended for removal, one was recommended for reseeding and one was recommended to be rebuilt closer to shore.

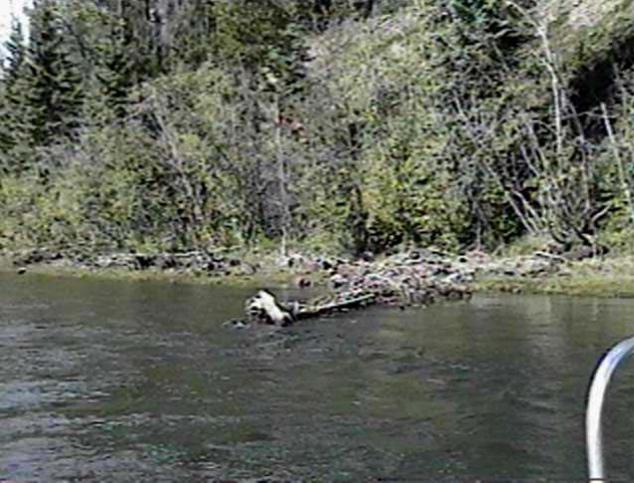
Sept.9,1997-LM 15.6 Rail Anchored Sweeper (82.6m³/s)
Constructed in 1991, this structure has captured a small amount of debris, and remained relatively stable although some material was lost in 1997.

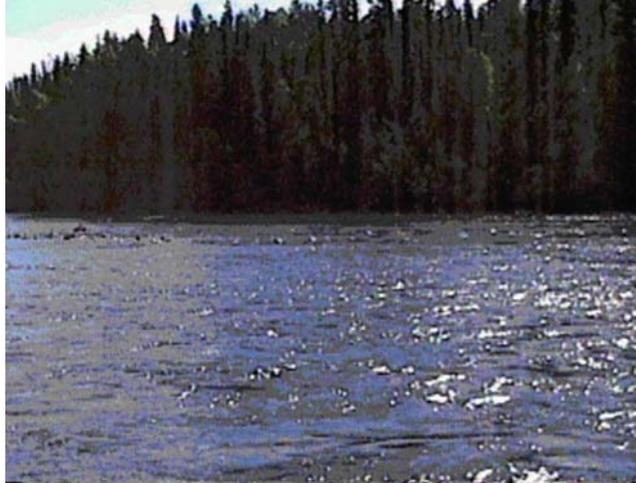
Sept. 9, 1997 - MC15.7 Pocket Pool (82.6m³/s)
Constructed in 1991, the pocket pool consists of a 1 meter deep depression, excavated into the substrate in an area of shallow water, and has remained relatively stable.

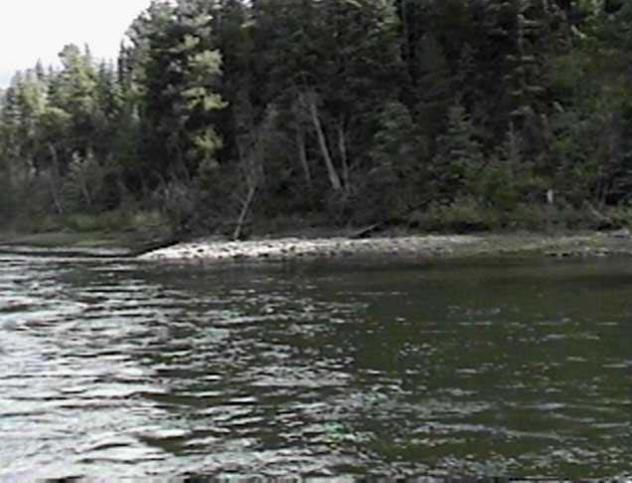
Sept. 9, 1997 - RM17.15 Point Bar (82.6m³/s)
Constructed in 1989 and modified in 1991, this point bar has remained stable.

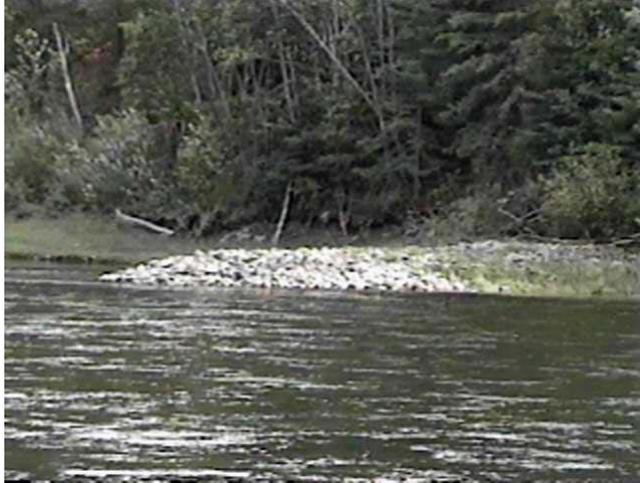
Sept. 9, 1997 - RM17.3 Point Bar (82.6m³/s)
Constructed in 1989, and modified in 1991, this point bar has remained stable

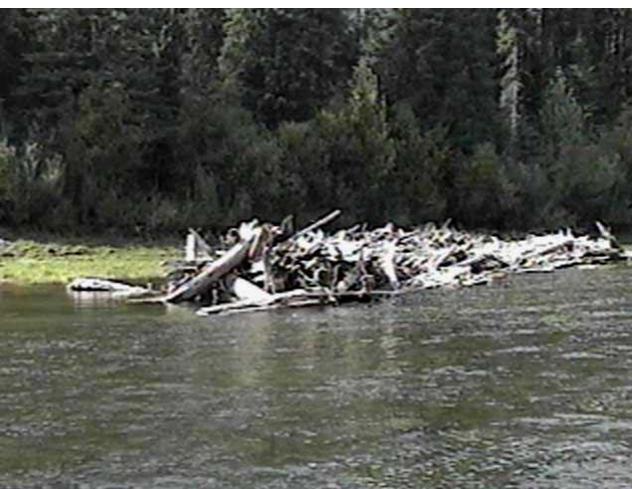
Sept. 9, 1997 - LM17.9 Debris Boom (82.6m³/s)
Constructed in 1990, this structure prevents excess material from entering the side channel and causing a blockage of flow. It has trapped a large amount of material but is located in shallow water.

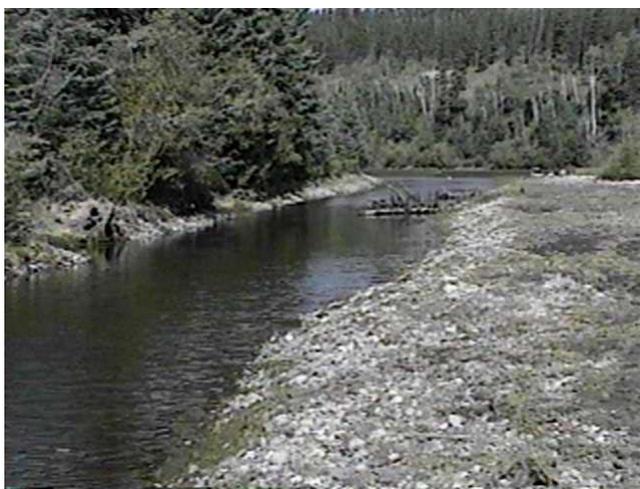
Sept. 9, 1997 - RM17.9 Side Channel (82.6m³/s)
Constructed in 1988 and modified in 1990 to remove material that was reducing velocities, the side channel currently has extremely low velocities due to a beaver dam at approximately the mid point of the channel.

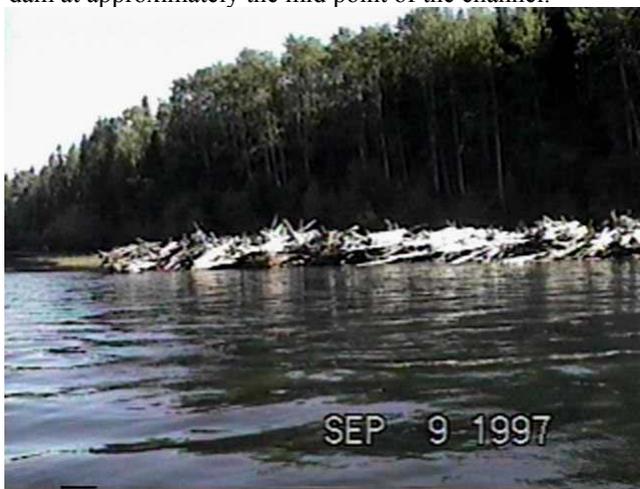
Sept. 9, 1997 - RM20.05 Rail Debris Catcher (82.6m³/s)
Constructed in 1991, this structure trapped a large amount of debris within the wetted area, and on shore immediately after construction. It has remained stable since that time.

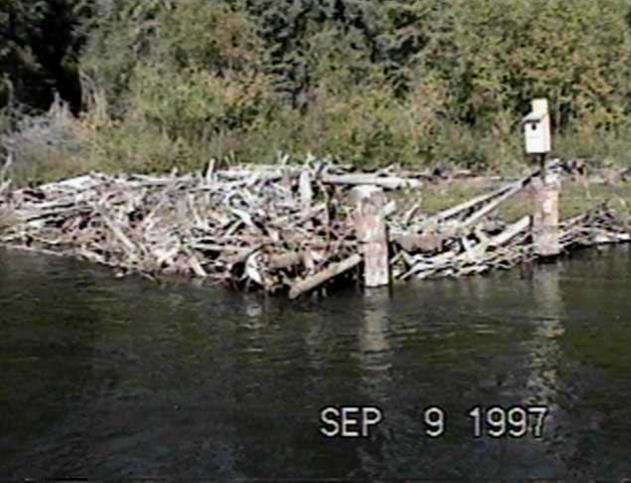
Sept. 9, 1997 - LM21.3 Rail Debris Catcher (82.6m³/s)
Constructed in 1990 this structure had preliminary debris retention problems, but after three modifications and reseeded efforts the structure has slowly increased the amount of captured debris and has remained stable.

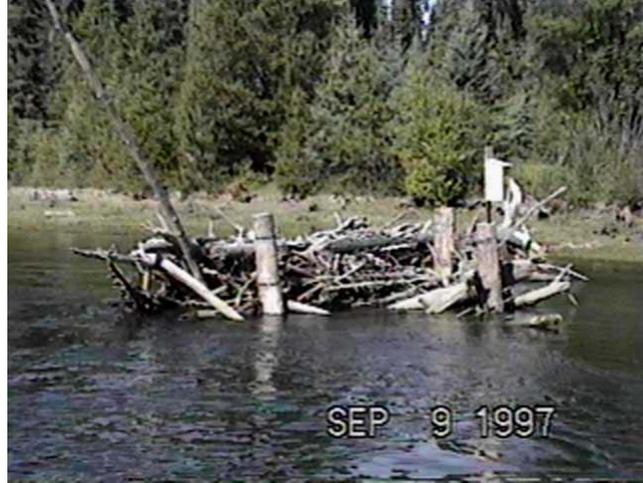
Sept. 9, 1997 - LM21.4 Rail Debris Catcher (82.6m³/s)
Constructed in 1990, this structure trapped a large amount of debris after construction and was colonized by beavers in 1996.

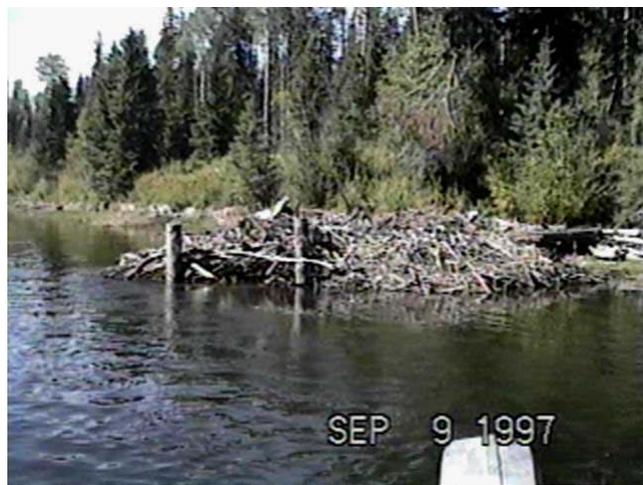
Sept. 9, 1997 - LM22.6 Rail Debris Catcher (82.6m³/s)
Constructed in 1990, this structure captured a large amount of material after construction and was colonized by beavers. The structure has remained stable.

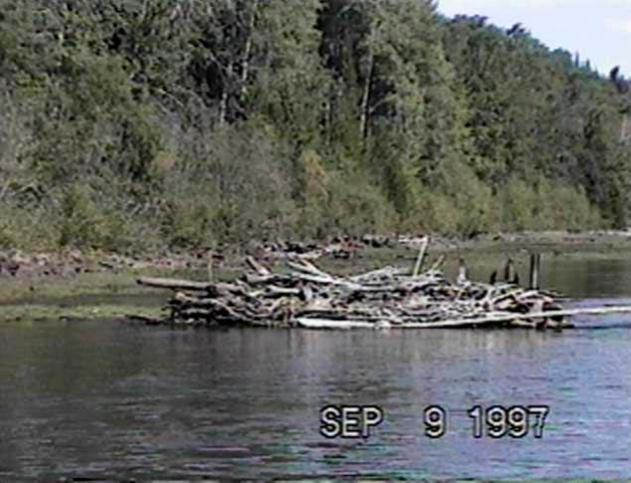
Sept. 9, 1997 - LM 22.85 Rail Debris Catcher (82.6m³/s)
Constructed in 1990, this structure has slowly accumulated woody debris and continues to remain stable.

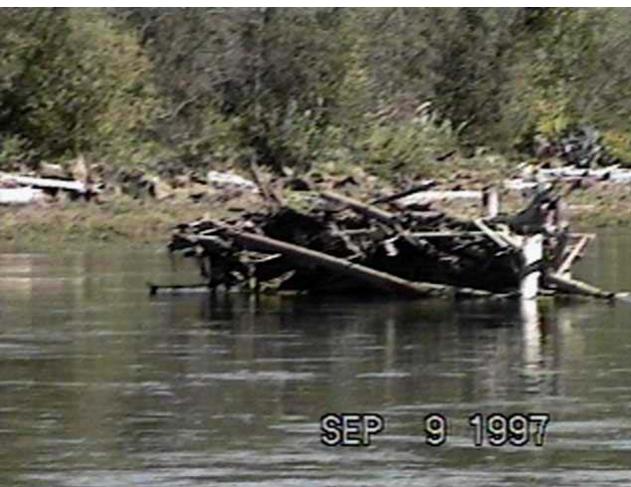
Sept. 9, 1997 - LM24.3 Rail Debris Catcher (82.6m³/s)
Constructed in 1990, this structure originally did not trap much woody debris, but over time has accumulated material and has remained stable.

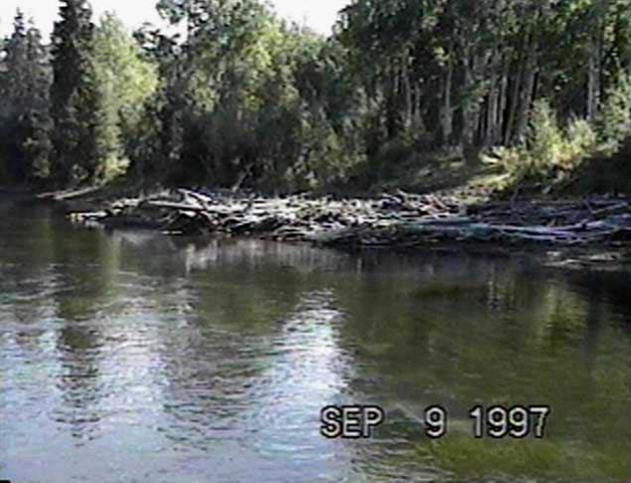
Sept. 9, 1997 - RM24.4 Floating Crib (82.6m³/s)
Constructed in 1988, this structure has trapped some material on shore, and was colonized by beavers after construction. However beavers have not utilized the structure for several years.

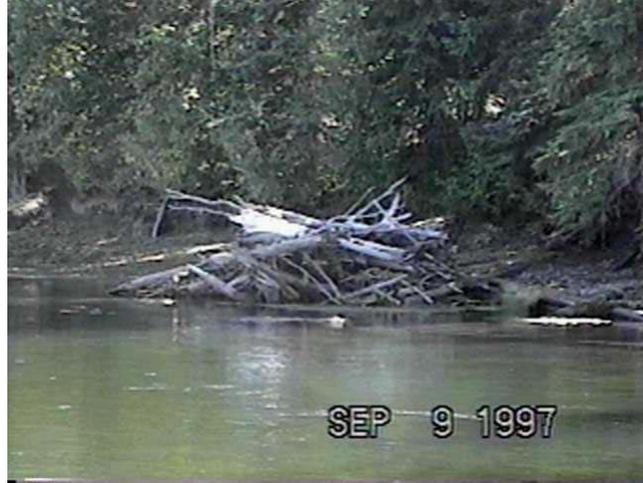
Sept. 9, 1997 - RM24.6 Pseudo Beaver Lodge (82.6m³/s)
Constructed in 1989, this structure had some success with debris entrapment. It is currently maintaining a small pile of woody debris.

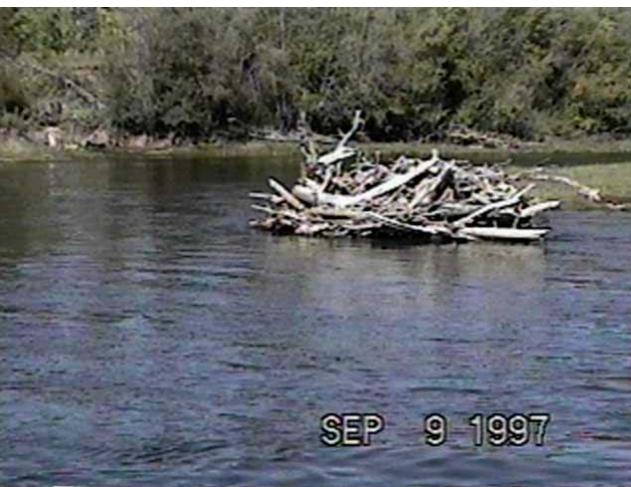
Sept. 9, 1997 - MC25.7 Rail debris Catcher (82.6m³/s)
Constructed in 1991, this structure has accumulated a small amount of material, and has remained relatively stable over time.

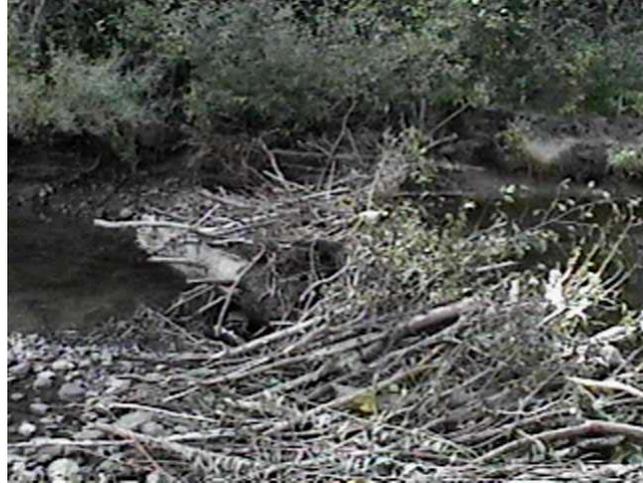
Sept. 9, 1997 – RM17.9 Side Channel (82.6m³/s)
This beaver dam located at approximately the mid point of the side channel effectively blocks the majority of the flow and reduces velocities in the channel to near zero.

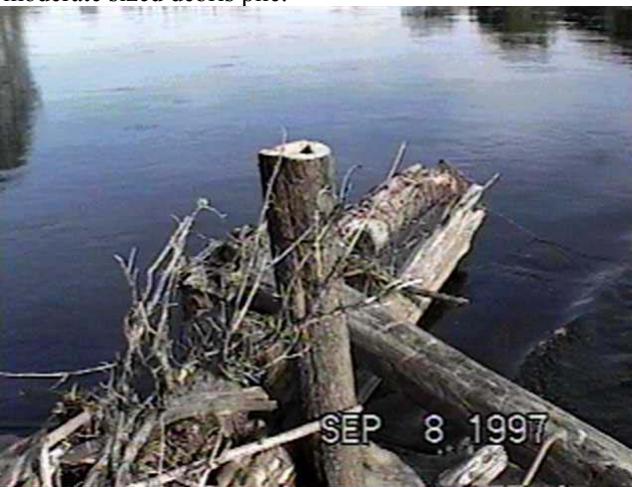
Sept. 8, 1997 – Rail Covers
Rail covers were designed and tested in 1997 to improve the esthetics of habitat complexes by giving the rails the appearance of a natural log. V-Groove and slab rail covers were installed on 10 and 6 rails respectively.

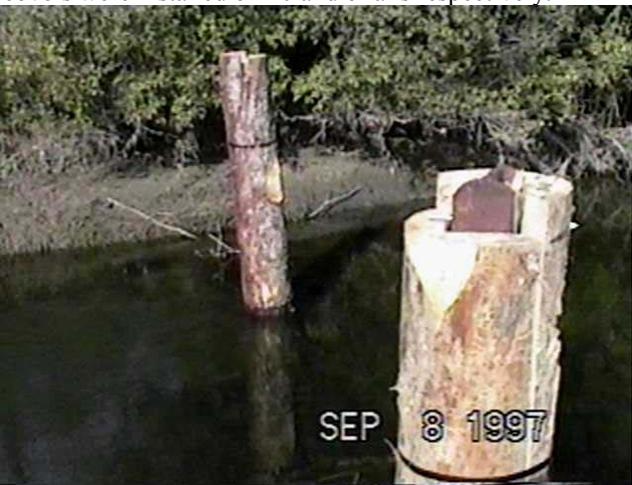
Sept. 8, 1997 – V-Groove Rail Covers
To install V-groove rail covers the two halves of the logs were fastened around the rail with banding wire and were bolted through the top of the rail to prevent lifting.

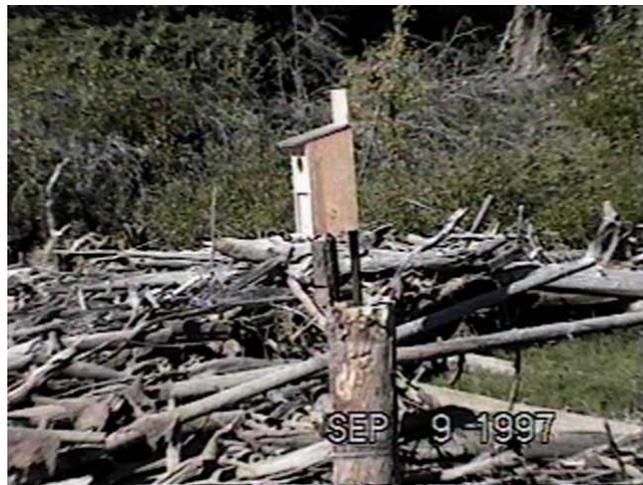
Sept. 9, 1997 – Typical Nesting Box
Nesting boxes were installed on 7 rails in 1997 in an effort to improve esthetics and provide habitat for cavity nesting waterfowl such as Buffleheads and Goldeneye.
